IBHS Early Insights

Lahaina Fire—2023

Insurance Institute for Business & Home Safety (IBHS)

August 2023

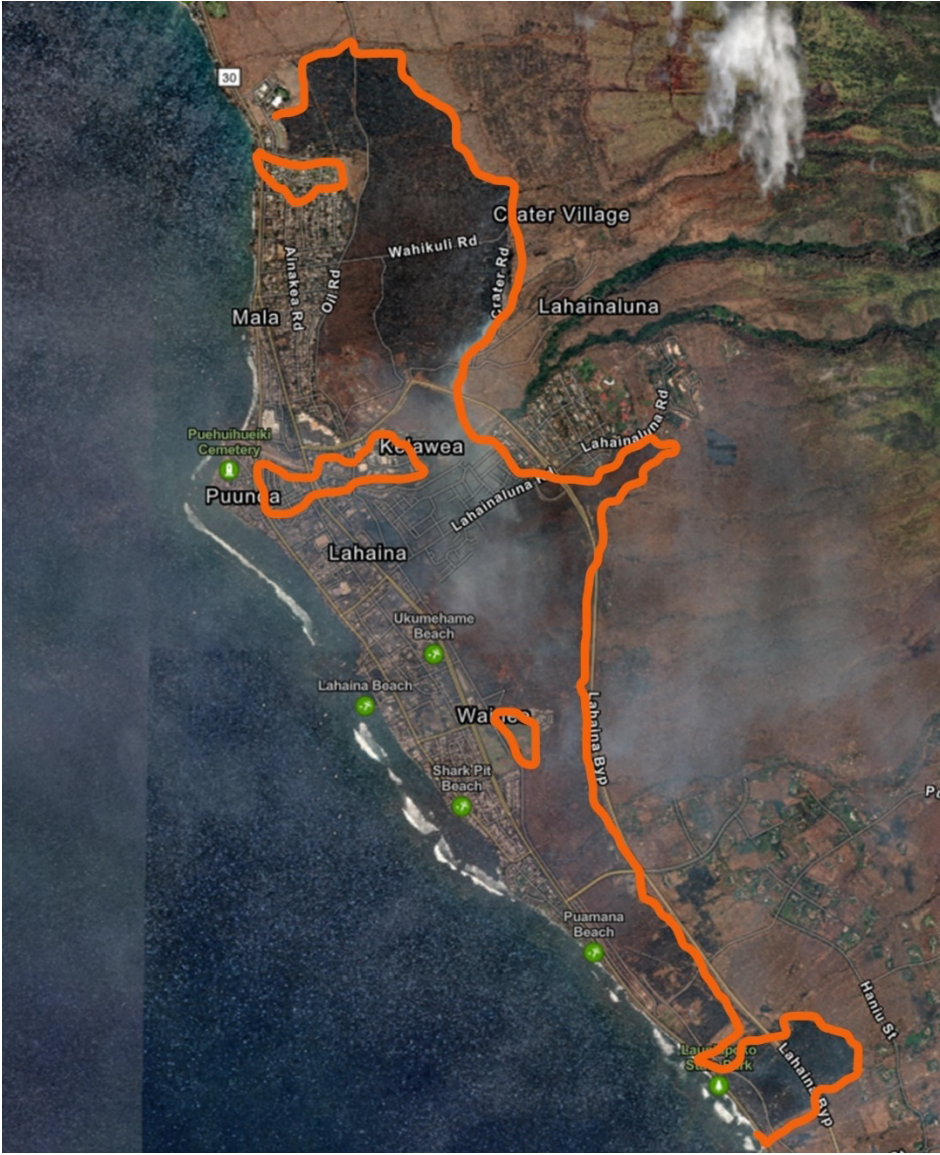
With over 2,200 structures destroyed, the Lahaina Fire is the seventh most damaging fire in the United States, based on structures destroyed, since 1990. The number of destroyed structures represents nearly three-quarters of all buildings in the community. Figure 1 provides a post-fire satellite view along with the estimated fire boundary and areas within Lahaina that survived (orange lines).

Figure 1: Post-fire satellite image showing the boundary of the Lahaina Fire and larger areas within the community that survived (orange lines). Imagery courtesy of Maxar.

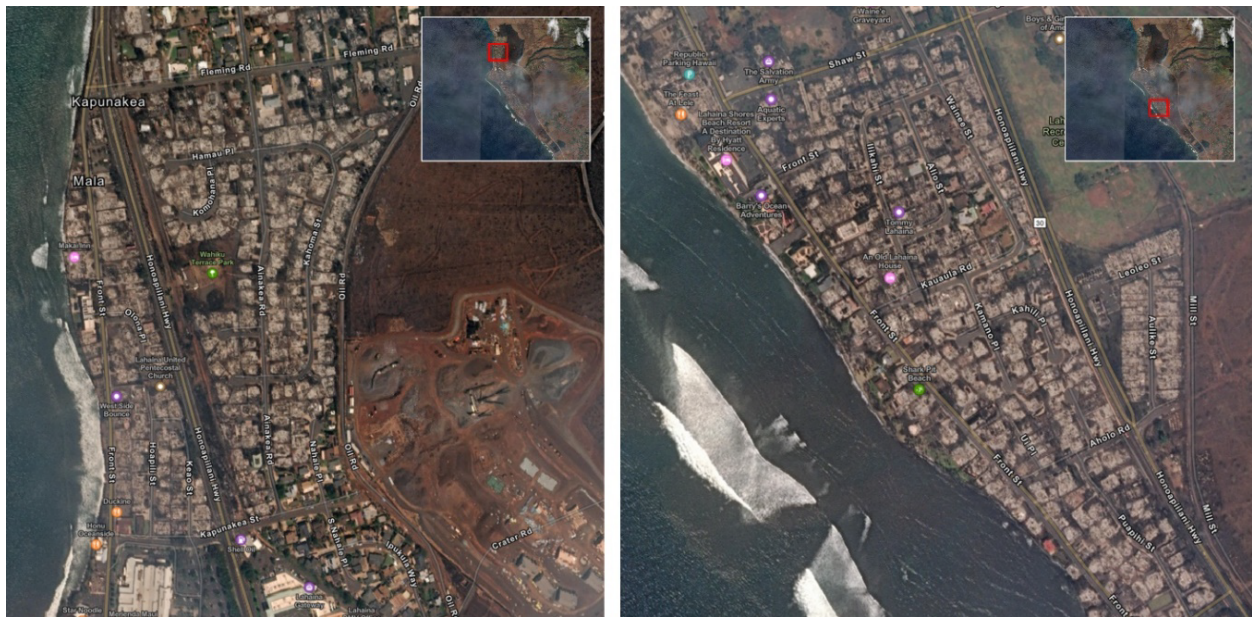
Post-fire satellite imagery courtesy of Maxar and Umbra Space synthetic aperture radar data does suggest varying degrees of fire exposure and severity within the community. An example of this is shown in the northern residential areas of Lahaina, north of Malanai Street (Figure 2 - left).

Figure 2: Satellite imagery of two areas where some of the most intense fire exposure possibly occurred, (left) south of Fleming Rd. to Kapunakea St. and (right) the area south of Shaw Street and bounded on the east side by the Honoapiilani Highway, including along Front Street. Satellite imagery courtesy of Maxar.

In this area of mostly single-family homes, the fire intensity was not enough to consume all vegetation and the presence of some sporadic homes that survived suggests that ember-driven ignitions (from both vegetative and structural fuels) may have been the dominant spread mechanism. This area also had structure spacing ranging from approximately 11 ft to greater than 25 ft for a few parcels.

South of Fleming Road, in a slightly denser area of older single-family homes, imagery indicates a more intense fire, with little materials remaining. In this area, all three ignition mechanisms (ember attack from structural fuels, direct flame contact, and radiant heat) were likely present and each were substantial contributors to the intense fire. It is likely fire spread from this area into the historic structures along Front Street. Pier and beam construction was common in this section of Lahaina. Wood lattice often surrounded the elevated structures along with a larger number of elevated decks. Vegetation coverage was near or greater than 50% on many parcels.

Fire ultimately spread through nearly the entire community, with another area of intense fire noted in the residential areas at the southern extent of Lahaina (Figure 2-right). The area south of Shaw Street and bounded on the east side by the Honoapiilani Highway, including along Front Street, appeared to also experience some of the most extreme fire conditions.

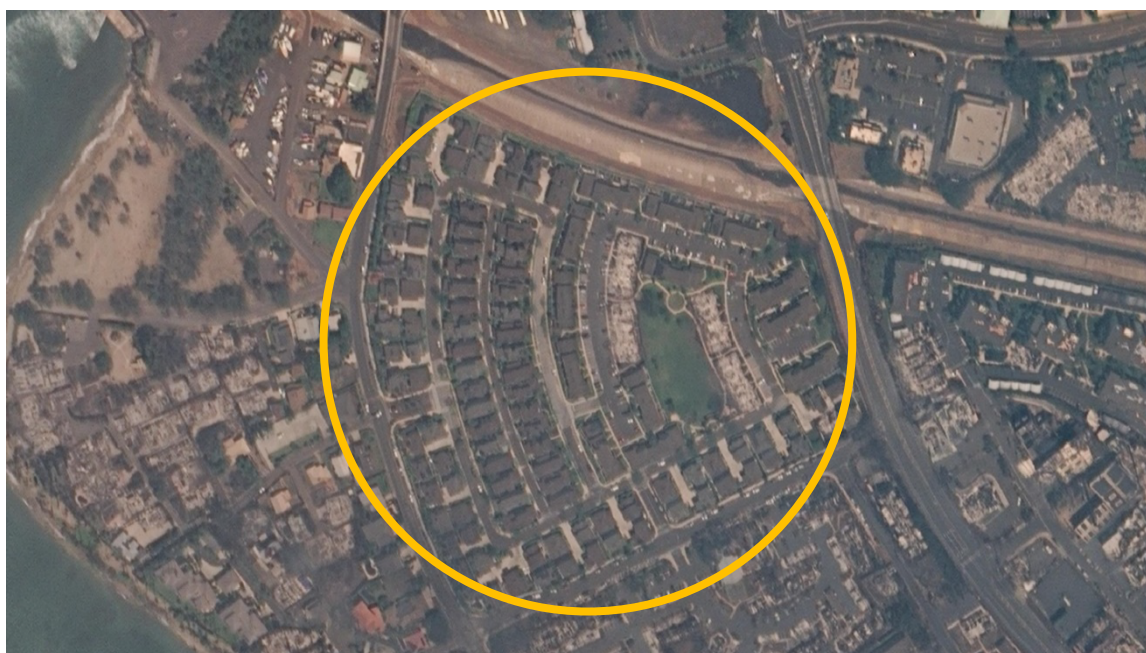
The most notable success story was a new development, built in 2019-2020. This neighborhood had single-family home construction with multi-family units in its interior. The development is located immediately south of the Kahoma stream channel and bordered by Front Street on the west, the Honoapiilani Highway to the east, and Kenui Street on the south side (see Figure 3). Within this development, no single-family structures were lost, but four multi-family structures in its interior ignited (initially likely from embers), but a structure-to-structure conflagration was avoided in this area.

Figure 3: Post-fire satellite image of a new development, built in 2019-2020, that survived the Lahaina Fire. Note the four multifamily structures within the development that were destroyed. The initial ignition here was likely ember-driven, but a structure-to-structure conflagration scenario did not unfold here. Imagery courtesy of Maxar.

- Upwind fire and ember break from commercial construction and the Kahoma Stream channel.
- Class A roof covers, specifically asphalt shingles and metal.
- Non-combustible wall cover materials

- High wind-rated off-ridge attic vents (for wind and wind-driven rain mitigation). IBHS tests have shown that these vents are effective at reducing ember entry³.
- Less dense connective fuels between structures, including vegetation.
- Vegetation, due to the new construction, was less mature, with lower areal coverage compared to other residential areas in the community.

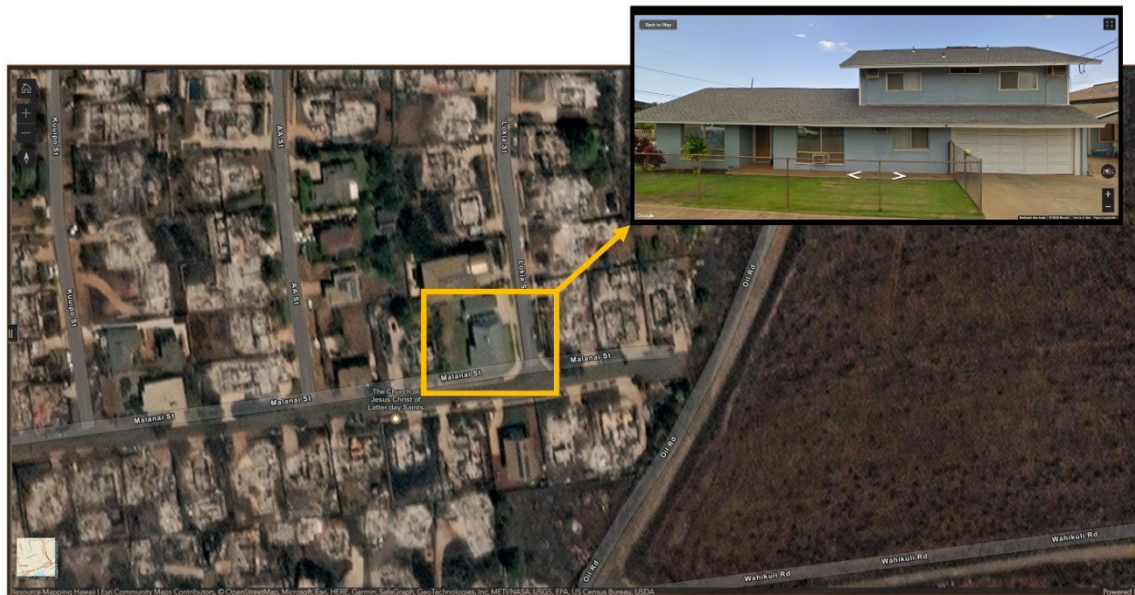
Elsewhere, in the areas where fire exposure was not extreme, some individual structures survived amidst those that were destroyed, indicative of the sometimes-random nature of ember attack as a dominant ignition mechanism. In these cases, fuel density in the 0 to 5-foot zone was often less than neighboring structures, the presence of non-combustible wall materials, or structure separation distances greater than 40 feet. An example of a home that survived within an area of intense fire is shown in Figure 4.

Figure 4: An example of a home that survive, with low density fuel coverage, especially in the 0-5-foot home ignition zone, an asphalt shingle roof, and non-combustible concrete masonry unit wall material. Post-fire imagery courtesy of Maxar and pre-fire condition image courtesy of Google-Street View.
