Hurricane Harvey Wind Damage Investigation

Insurance Institute for Business & Home Safety

JULY 2018

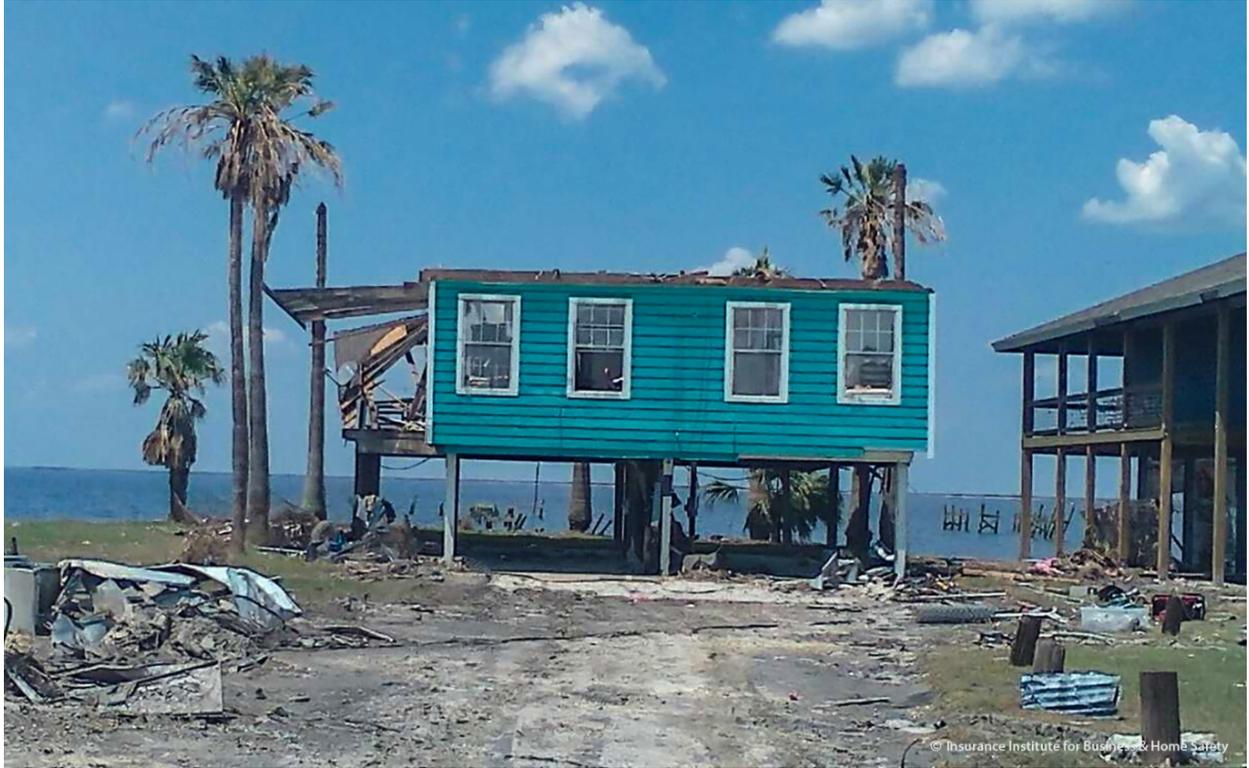
Structures such as porches, sunrooms, pool cages, and others are frequently attached to the primary residential building. The connections between the primary and attached structures are often weak or inadequate. Consequently, damage to attached structures is common in wind events and in many cases, causes additional damage to the primary building, such as the example in Figure 8 from Holiday Beach.

Figure 8. Example of an attached porch that was damaged and may have caused additional damage to the roof of the main building.

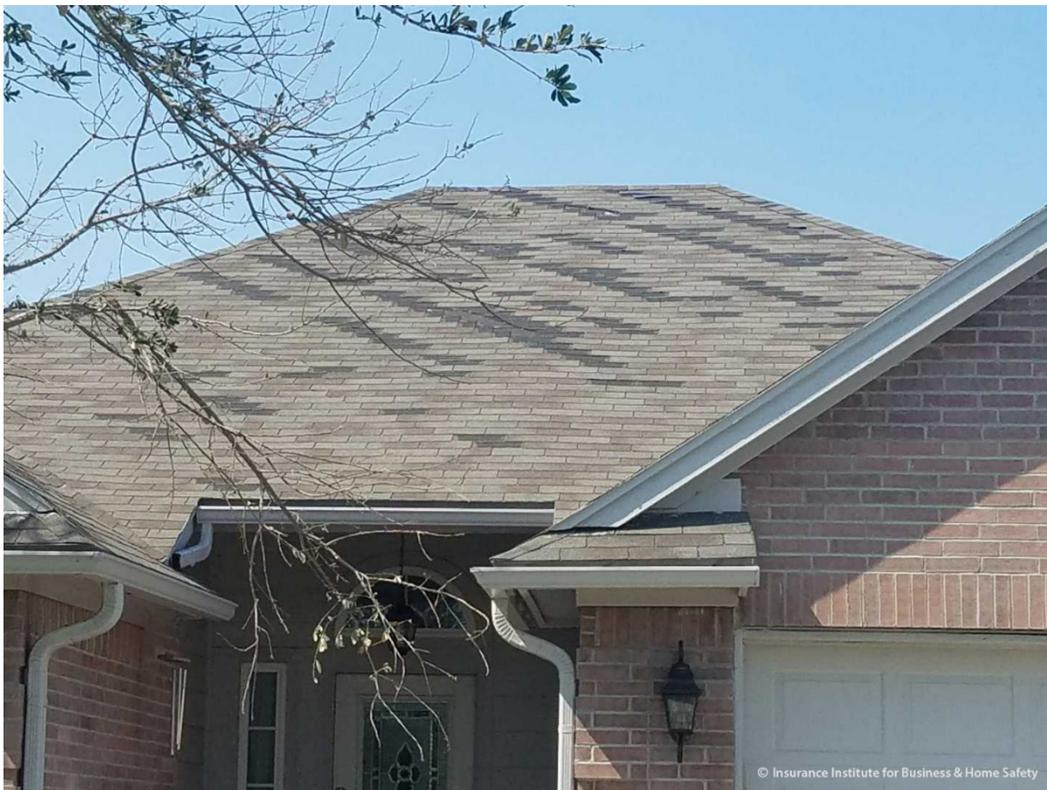
- The southeast neighborhood had only 3-tab shingle roofs, and they all displayed a classic pattern of diagonal tab loss (see Figure 16) following the pattern of unsealing noted by Dixon et al. (2014).

Figure 16. Example of diagonal damage to 3-tab shingles, which have been shown by Dixon et al. (2014) to occur most frequently at the end of the shingle and oriented along the pattern of installation.

- 3-tab shingle damage occurred on every home investigated in Rockport Southeast, Port Aransas South and Rockport Northwest. Damage often included a diagonal loss pattern along the end of shingle strips, consistent with unsealing of shingles that often occurs with typical aging and weathering effects that follow along the installation pattern.

- As the most common damage mode, these roofs would benefit from a sealed roof deck to keep water out.
- Roof slope and shape did not appear to contribute to roof cover loss.

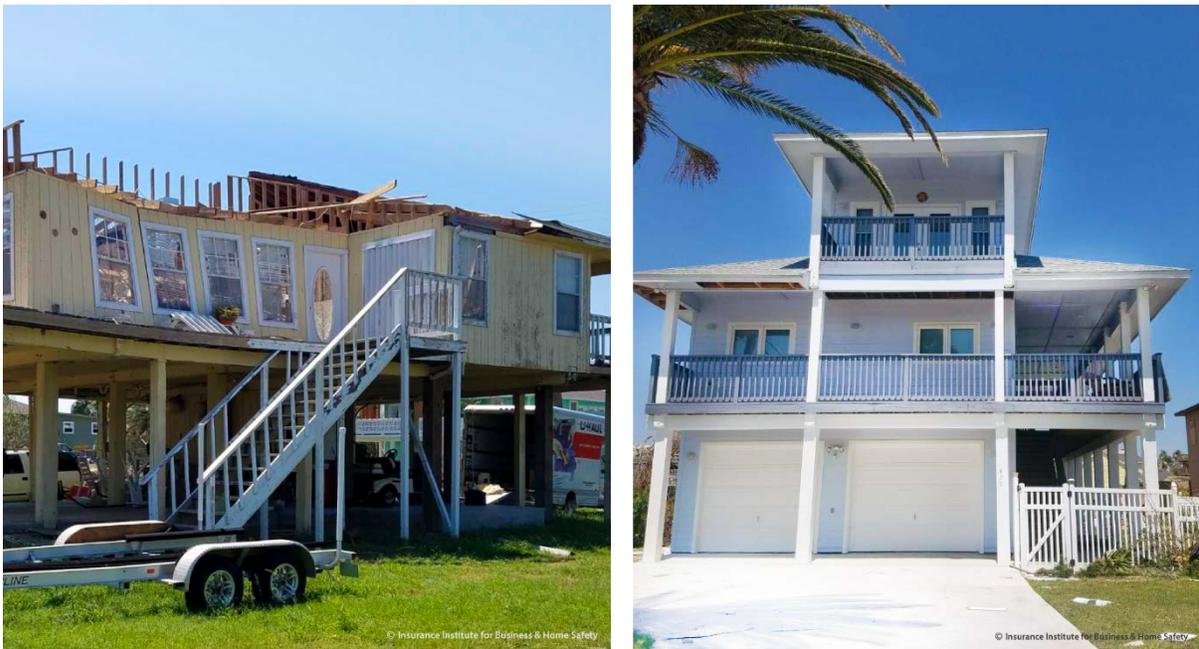
The IBHS team noted generally better performance of both residential and commercial buildings in areas of newer construction compared to older construction. Examples are shown in Figure 25 and Figure 26.

Figure 25. Performance comparison for two homes located 250 feet apart in Port Aransas North, built in 1987 (left) and 2006 (right). These two structures likely experienced very similar wind conditions.

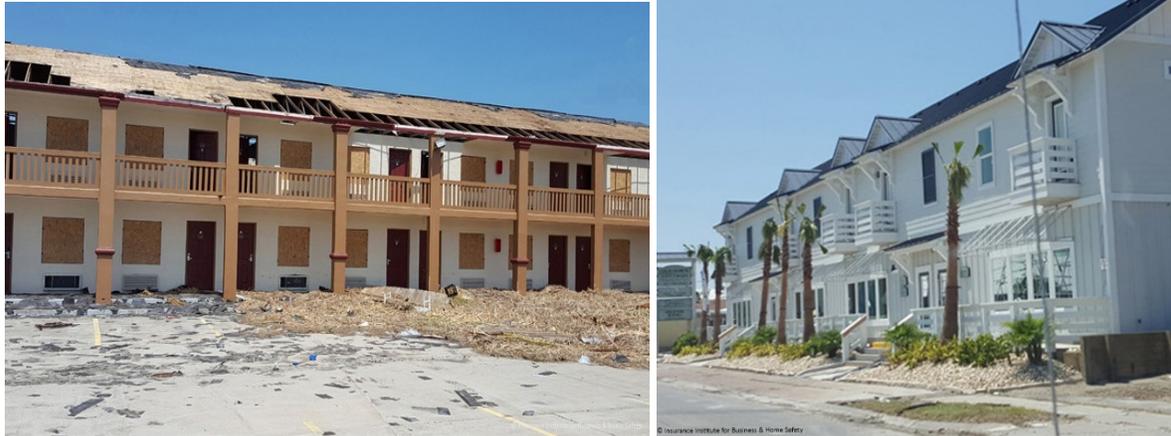
Figure 26. Performance comparison for two commercial structures located about 1 mile apart in Port Aransas, built in 1984 (left) and 2017 (right).
