Insurance
Institute for
Business &
Home
Safety®

ATTACHED STRUCTURES HIGH WIND RESEARCH

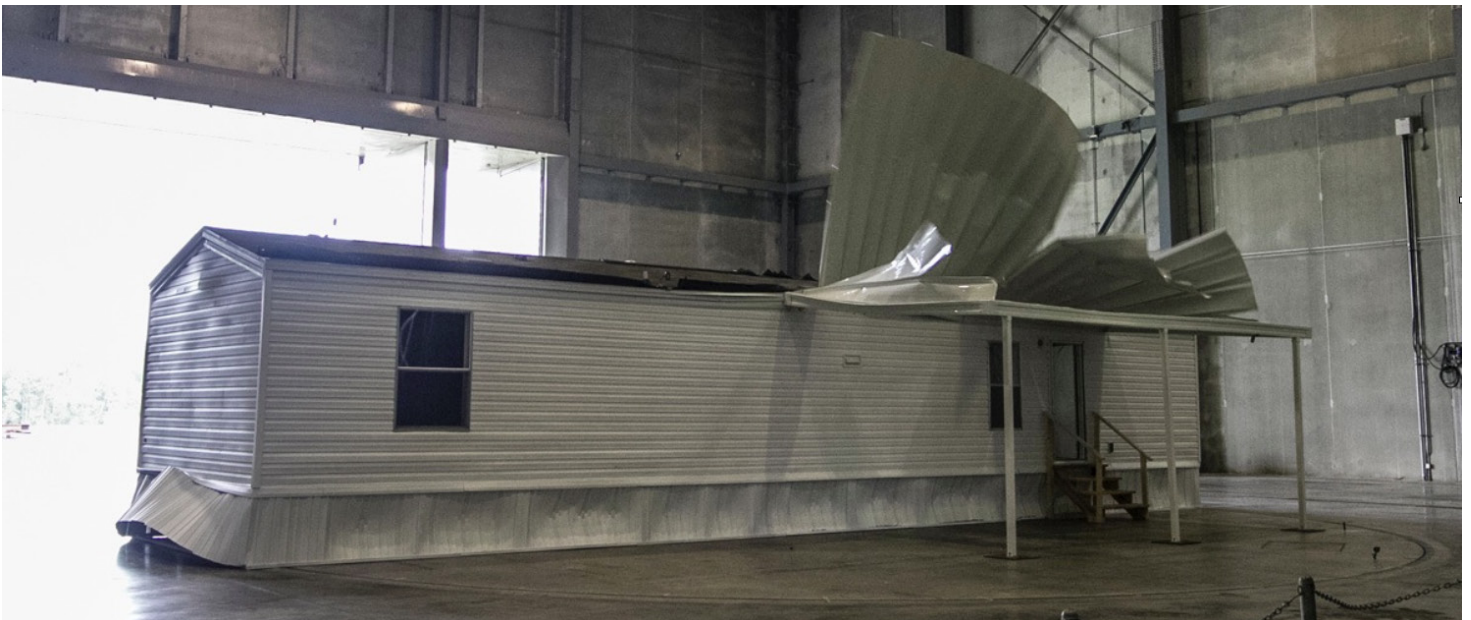
Figure 7. Failure of connections between roof pans and support beam at roof eave.

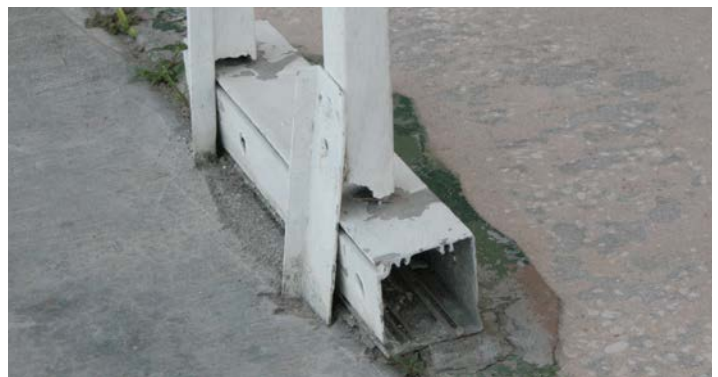
Figure 11. Damaged decorative support with weak repair attempt of connection/support at base.

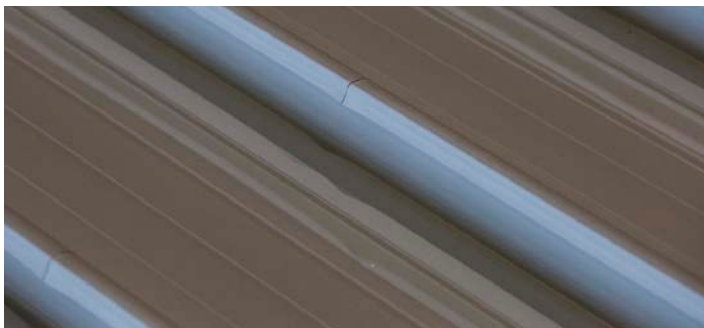
Figure 8. Cracking of roof pans caused by wind-induced vibration.

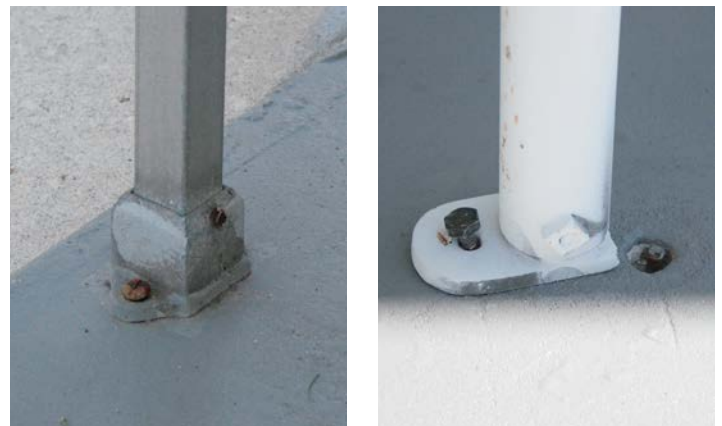
Figure 14. Other examples of poor post connections at base. Cast aluminum bracket (left) and broken bracket with dislodged screw (right). Note inadequate spacing of fasteners from each other.

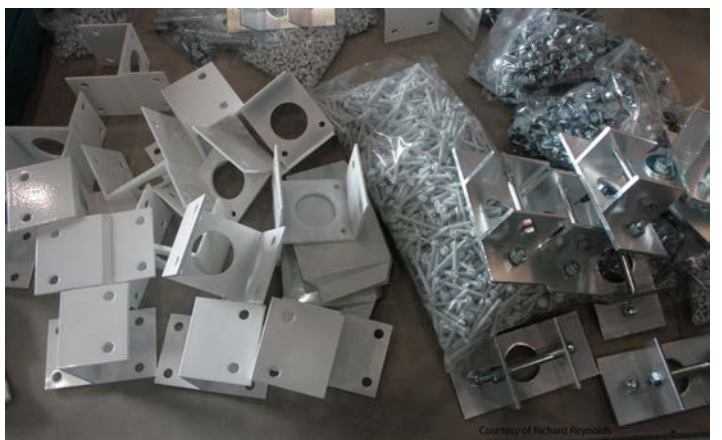
Figure 15. Assortment of commercially available brackets and fasteners for attaching posts to beams and foundations.

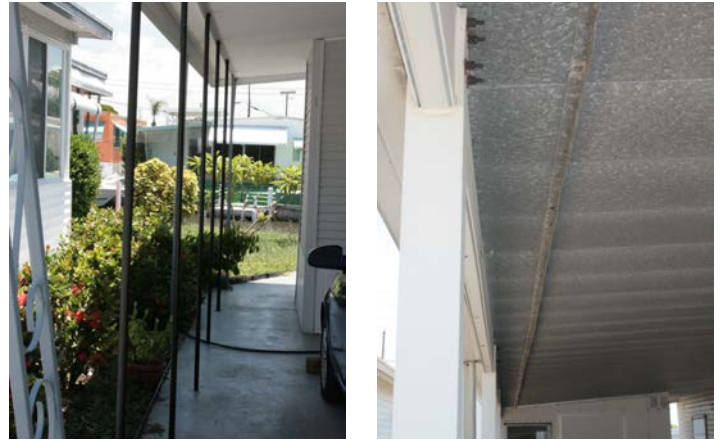
Figure 16. Left image shows typical old support system where pipe posts connect to small thin angle. Right image shows carport with replacement beam and 3" x 3" posts; note severely rusted bolts.

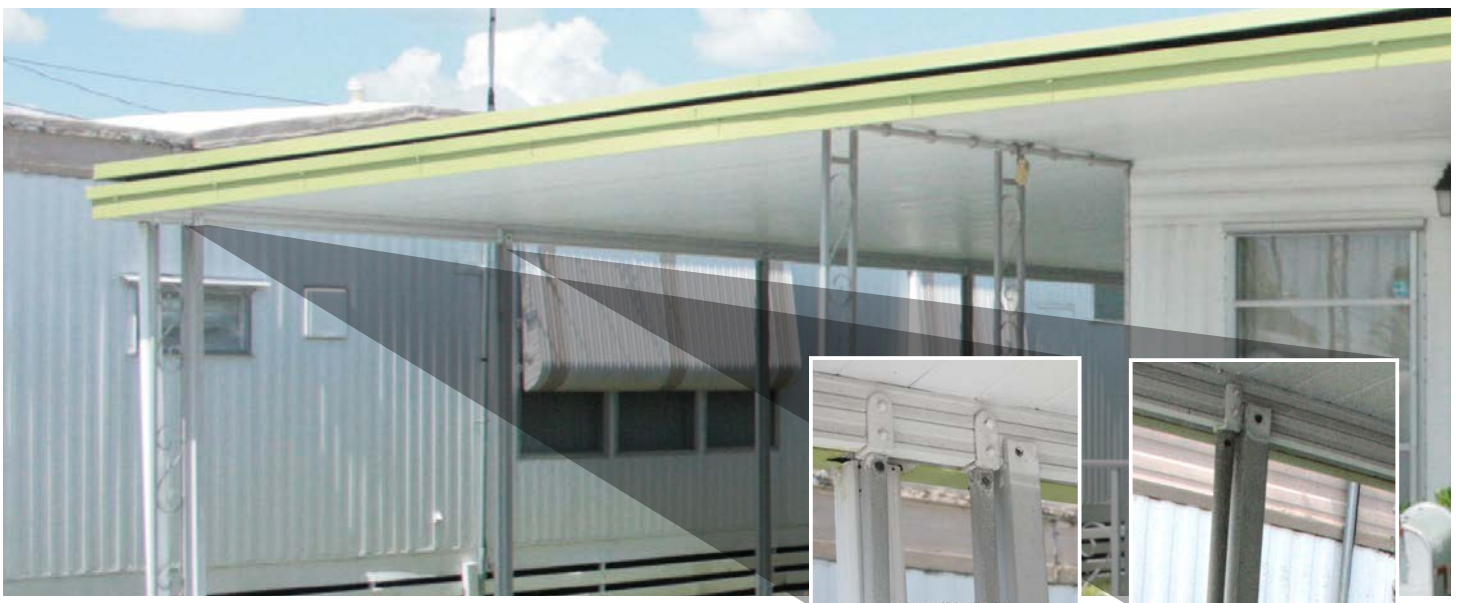
Figure 18. Posts added next to existing decorative post and pipe posts.

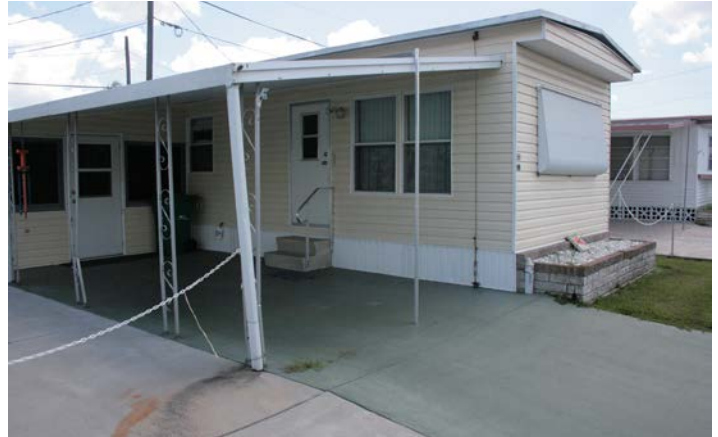
Figure 19. Angle attached to carport roof with temporary anchor post in place.

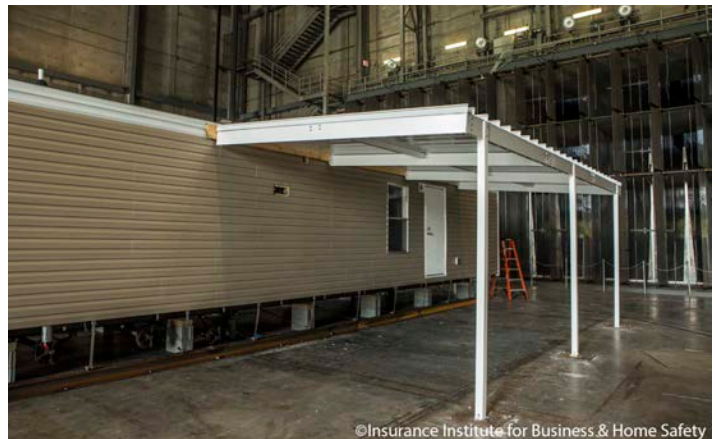
Figure 25. Photo of AAF-based design that withstood wind speeds in excess of 100 mph with no damage. Tests were conducted with both 0.024" and 0.032" thick pans, which were attached to beam between wall and eave using screws with metal/neoprene washers.

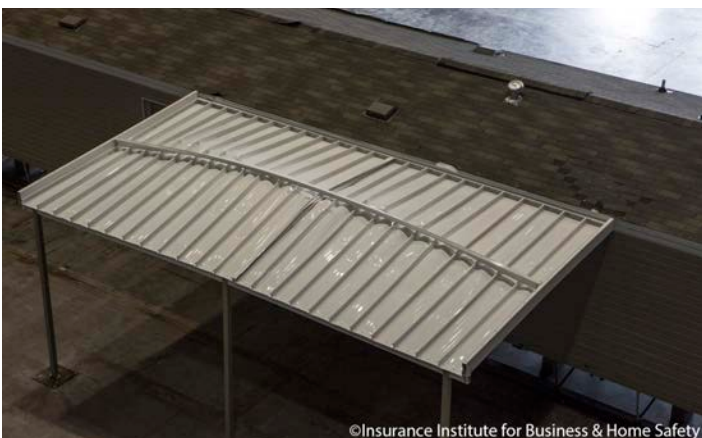
Figure 23. Roof buckled upward when subjected to 80-mph winds.

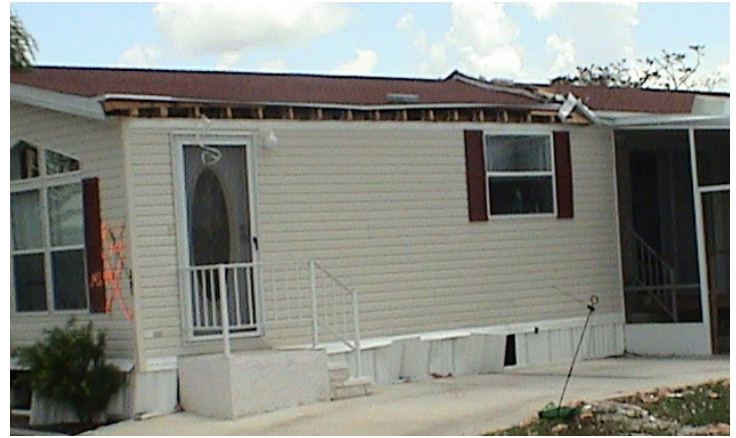
Figure 27. (Above) Typical damage to the eave of a home when a carport roof is blown away during a hurricane. About six square feet of area at the top of the wall was opened allowing entry of wind-driven rain.

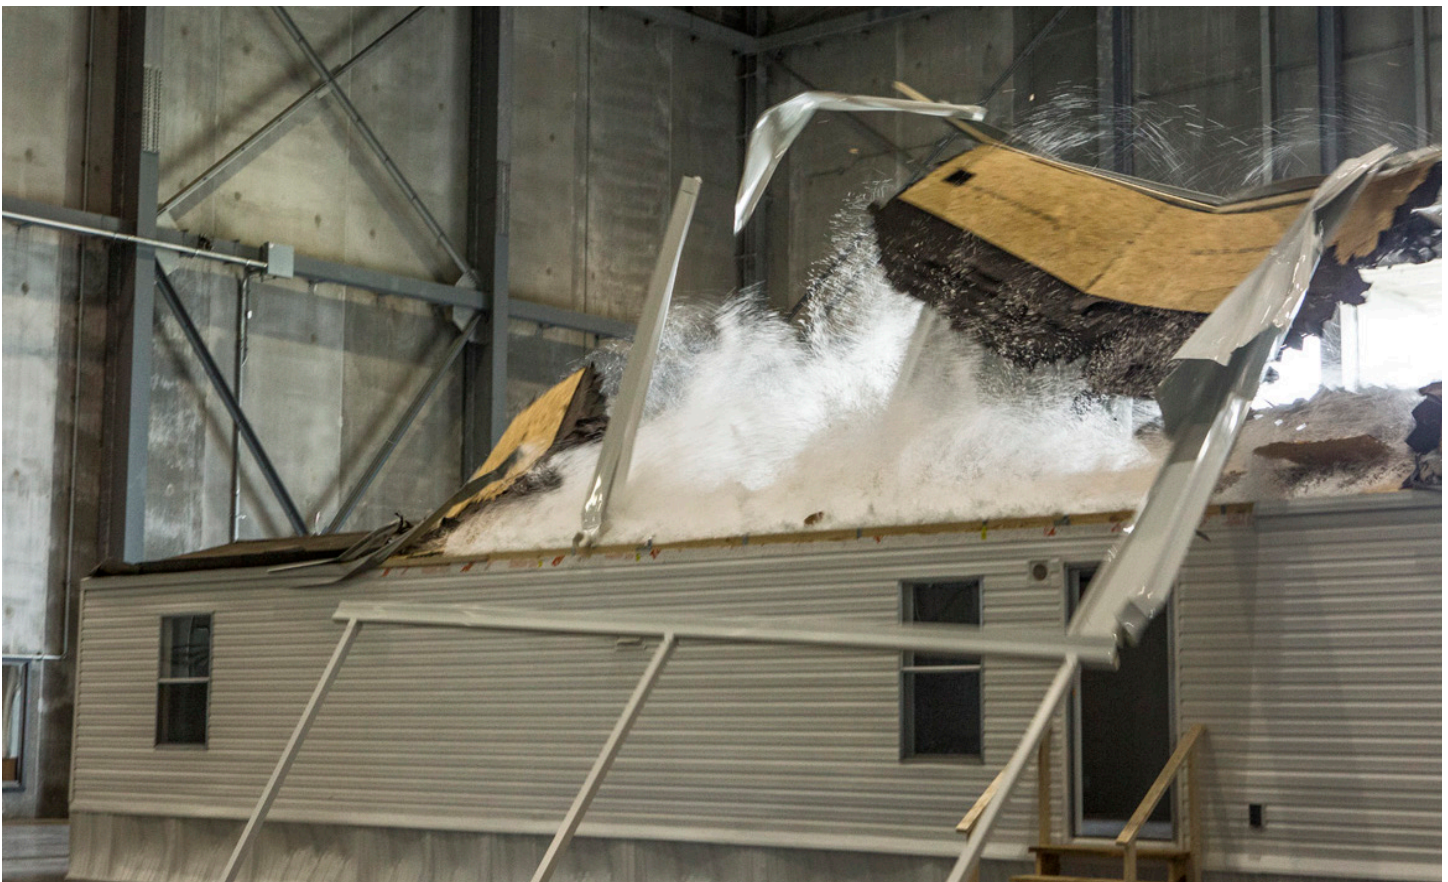
Figure 28. Detaching carport pulled roof sheathing from a manufactured home, introducing blown insulation (white) into the airstream.

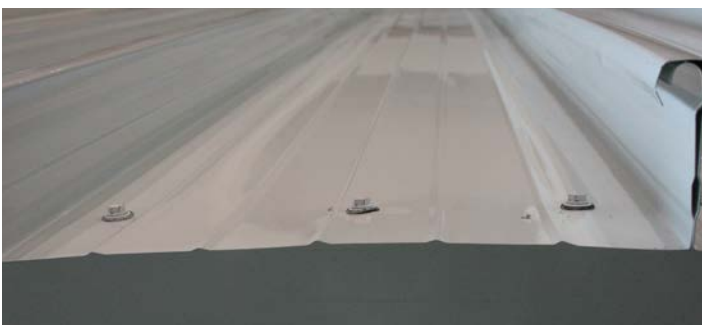
Figure 34. Initiation of panel connection failure at connections using small screws without metal/neoprene combination washers.

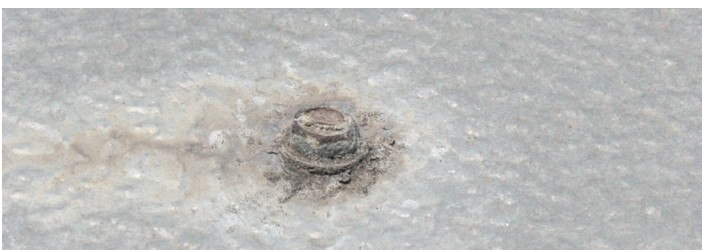
Figure 35. Corrosion around existing fastener without isolating neoprene layered washer.
