HURRICANE MICHAEL WIND DAMAGE ASSESSMENT

Executive Summary

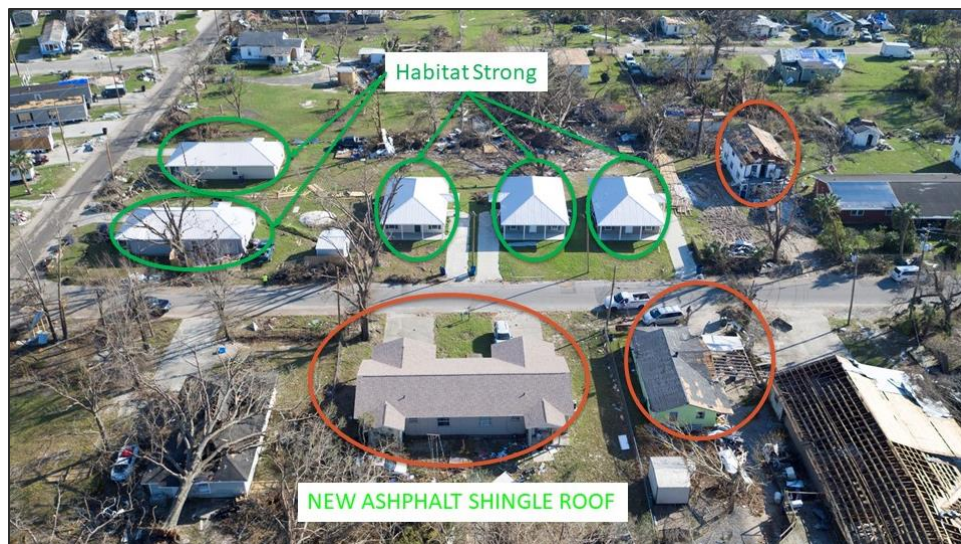
- Both FORTIFIED and Habitat Strong structures, built to exceed code, performed better than the surrounding structures built to standard codes at the time of construction. These successes show that it is possible for all homes, regardless of home value, to be built in ways that decrease losses and allow homeowners to return to their homes as quickly as possible.

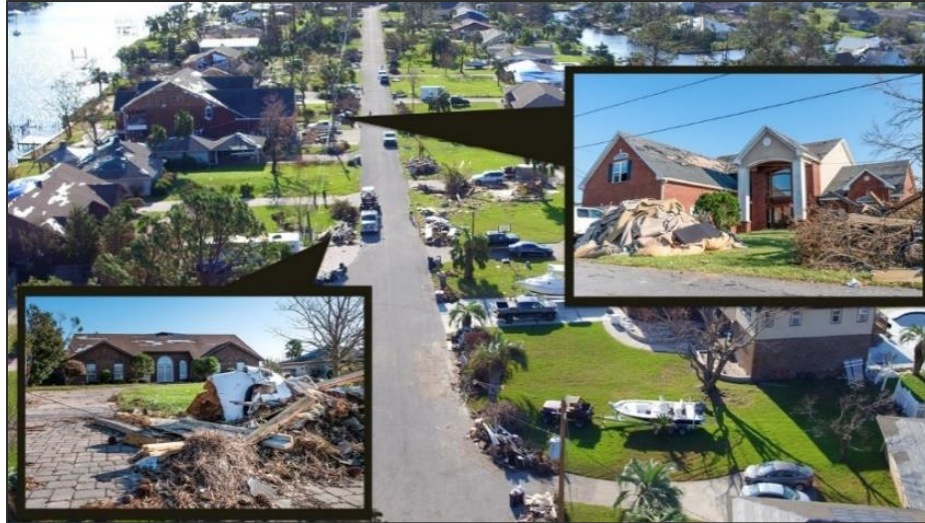
- Roof cover loss occurred in all wind speed bands. Most homes with asphalt shingles experienced damage, while less than half of homes with metal roofs were damaged. All homes with 3-tab shingles that were investigated were damaged.
- Evidence of water intrusion was present for many houses that lost roof cover and underlayment, highlighting the importance of a sealed roof deck in mitigating this type of loss.
