# STATE OF THE RISK: Interior Water Damage

*Insurance Institute for Business & Home Safety*

December 2024

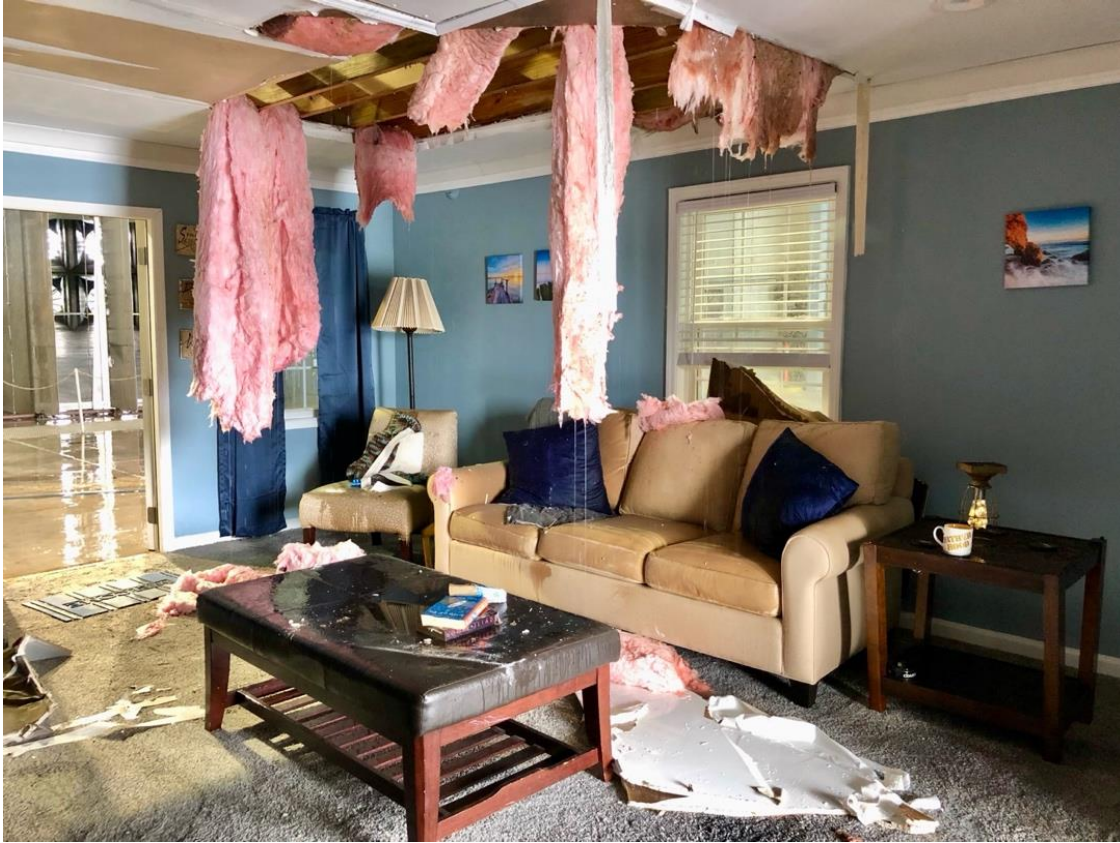
Figure 3. Photograph of interior water intrusion damage following a full-scale wind-driven rain simulation in 2019 at the IBHS Research Center.

The threat for water intrusion from wind-driven rain accompanies any windstorm. Wind-driven rain can infiltrate the building envelope of a home through damaged roof covers, vents, poorly installed or damaged flashing around roof penetrations, around windows and doors, and in extreme cases through damaged wall covers. The ability for wind-driven rain to amplify interior damage and losses is so substantial that it is one of the core perils that IBHS studies (Figure 3). In a limited claims study following the 2020 Midwest Derecho, Giammanco et al. (2023) found that when water intrusion occurred from wind-driven rain penetrating a damaged roof cover, total losses were 4 to 7 times greater than the cost to replace the damaged roof cover alone.<sup>12</sup> This loss amplification is also why a sealed roof deck is the cornerstone of the FORTIFIED Roof™ standard. The IBHS Research Advisory Council and Residential Committee sited continued losses from water intrusion due to wind-driven rain, most commonly in tropical cyclones. The two groups also noted an increase in wind-driven rain-related losses for windows and doors.

- Water entry through an unsealed roof deck with extreme roof cover damage (i.e., near 100%) was more than 3 times greater than water entry through a completely open soffit. While soffits are routinely damaged during windstorms, it is likely that water entry following damage to roof covers is the dominant driver of water intrusion for the roof system.<sup>9</sup>

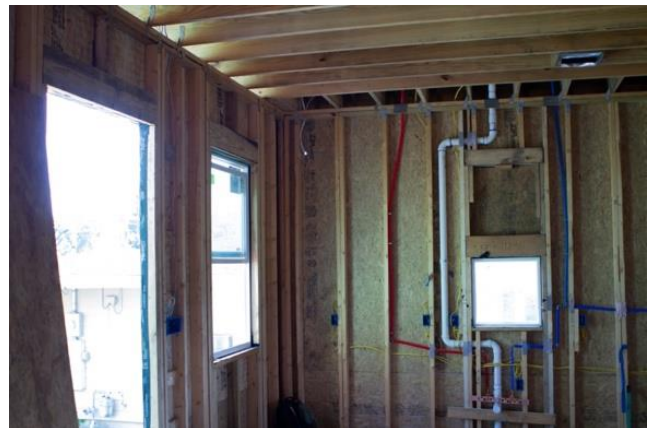
*Figure 6. Plumbing in exterior walls of a home under construction in Louisiana.*

- Plumbing along exterior walls adds to vulnerability to extreme cold.
- Crawl spaces and elevated foundations, including pier and beam construction, that create uninsulated areas underneath homes, including where plumbing lines may be, also increases vulnerabilities in extreme cold.

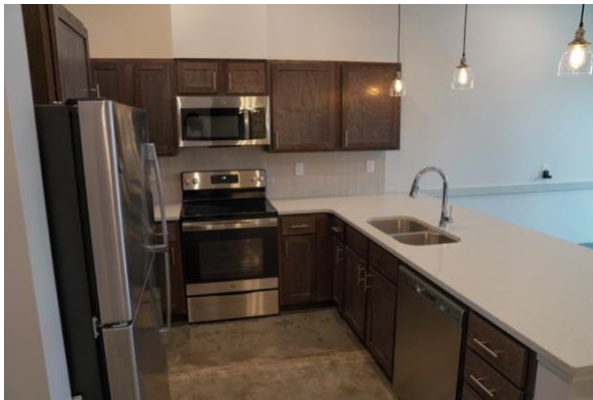
Figure 7. Example of a kitchen with appliances and plumbing connections that can contribute to interior water losses.

In today's modern appliances, most the of the water supply connections are achieved through flexible plastic hoses, often shrouded with stainless steel braid. The hoses use common metal or plastic threaded connectors with their associated internal rubber gaskets. Hoses could fail for a number of reasons spanning normal wear and tear, unintentional damage when moving appliances, too much water pressure, degradation of rubber or plastic materials due to exposure to extreme temperatures, and water quality issues.
