**Insurance
Institute for
Business &
Home
Safety®**

RELATIVE IMPACT RESISTANCE OF ASPHALT SHINGLES

Summary of UL 2218 Impact Tests

AUGUST 2014

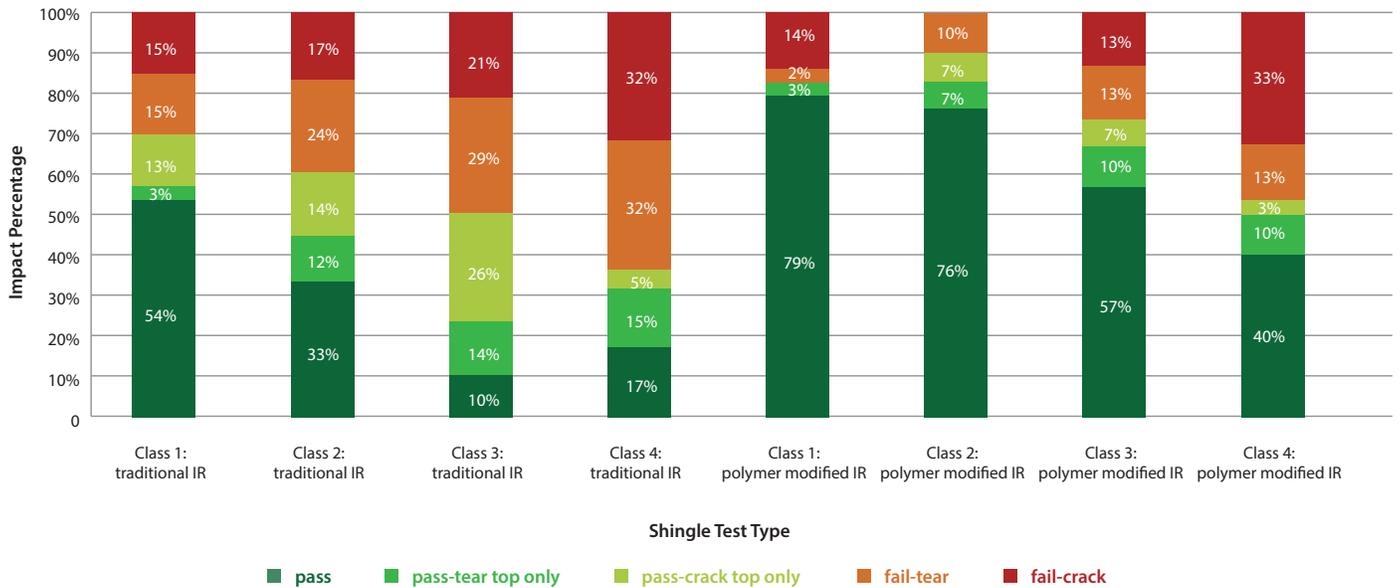
UL 2218 Performance Comparison:
Traditional IR vs. Polymer Modified IR Shingles

Figure 9: Detailed analysis of passing and failure modes for traditional IR and polymer modified IR shingles. It should be noted that the IR products are rated to withstand Class 4 impacts.

An example of this more detailed analysis is provided in Figure 9, which shows that the polymer modified IR shingles perform better in each impact test class than the traditional IR shingles. From this dataset, the polymer modified products are less likely than the traditional products to have a crack visible on the top without also being visible on the bottom. They also are less likely to exhibit tears at edges and corners and the dominant damage mode is cracking at joints and shingle centers.
