IBHS POST-EVENT INVESTIGATION:  
**CALIFORNIA WILDFIRES  
OF 2017 AND 2018**

July 2020

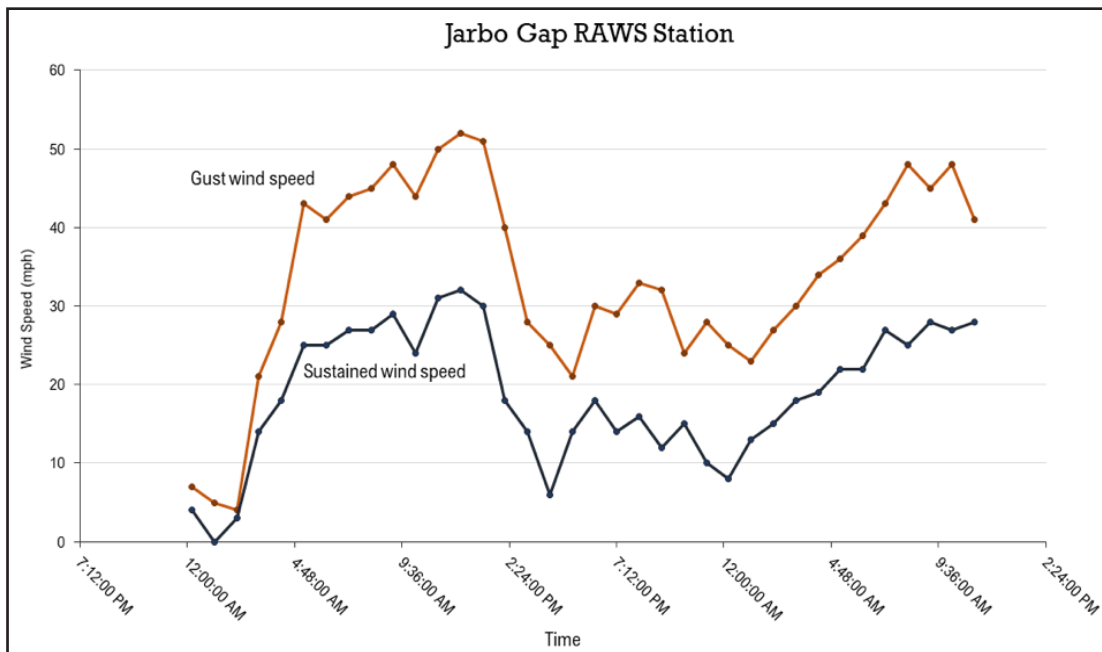
Figure 1. Hourly time history from Jarbo Gap Remote Automated Weather Station (RAWS) for wind gust (orange) and sustained wind speed (blue), 00 UTC 8 November through 12 UTC 9 November 2018.

The Camp Fire started on Thursday, November 8, 2018 at 6:45 a.m. PT, approximately 8 miles northeast of Paradise, California. Sustained winds of 25–30 mph, with gusts of 40–50 mph, drove rapid fire spread (Figure 1). The National Weather Service had already issued a red flag warning and relative humidity across the area was generally below 20 percent. The fire advanced nearly 15 miles in the first 12 hours, burning over 55,000 acres.<sup>8</sup> Within the first 2 hours, the fire front traversed nearly 4 miles and first affected the small community of Concow (approximately 6 miles northeast of Paradise).

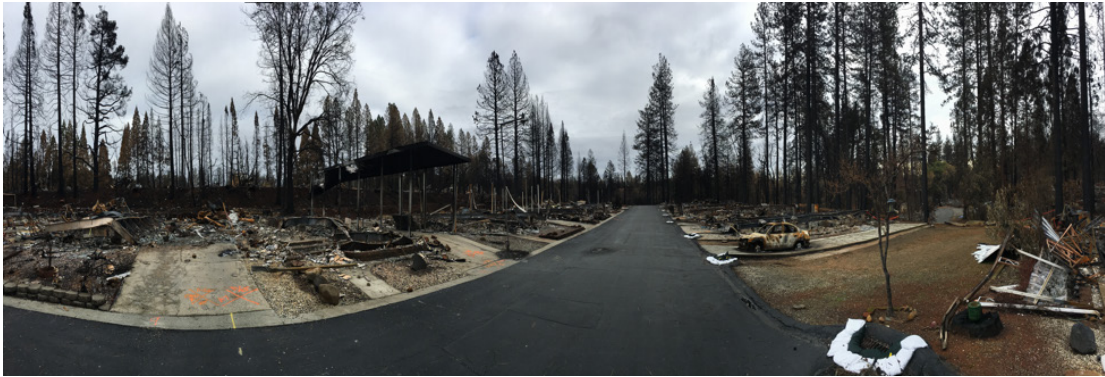
Figure 4. Panorama taken at a manufactured-home community on the east side of Paradise. Note tops (crowns) of evergreen trees still have visible pine needles.

Over the course of three days, the group conducted drive-by and site-specific investigations of the two communities. A general observation throughout the survey was that buildings were destroyed while vegetation remained (see Figure 4 on next page). The lack of a significant crowning fire suggests ember-driven ignitions of buildings with limited ground fuels, rather than the continuous burning of vegetative fuel throughout the the whole community.

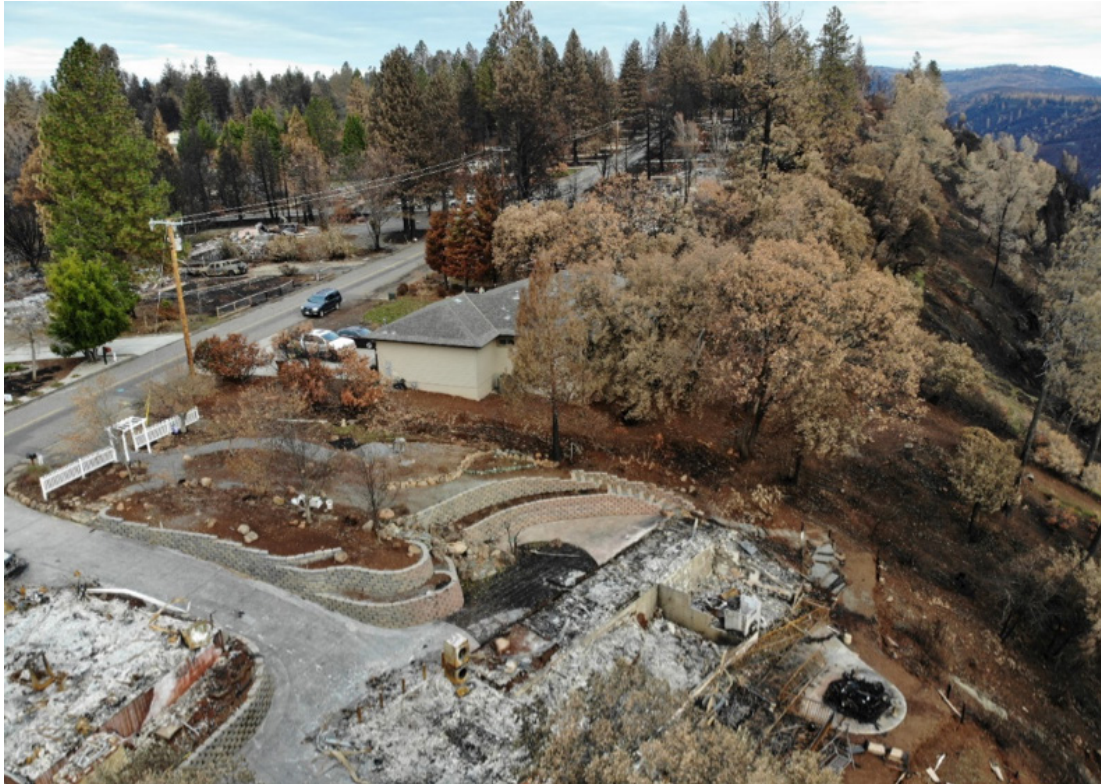
Topography is known to affect the spread of wildfires. Figure 5 depicts an oblique view of the east-facing slope of Paradise (Valley View Drive). As shown, all houses on top of the ridge are destroyed except one. When examining the pattern of charred vegetation, an unburned area between the two burned strips (highlighted in Figure 5) was found. The unburned area of terrain is located on a convex part of the escarpment. The two burned strips of vegetation have a concave shape. Fire spreads rapidly uphill. However, the local terrain shape of the small convex feature downhill from the home created a pathway for the flames and intense heat to flow around the home. This

small convex terrain feature likely reduced the exposure intensity on this one home and, coupled with its well-maintained mitigation features, enabled it to survive, while the other structures, at the edge of this ridge, experienced high-intensity fire spreading uphill that could overwhelm any mitigation strategies.

Figure 5. Home on the western edge in the community of Paradise, built after 2008 and to the California Building Code Chapter 7A requirements. Photograph courtesy of Munich Re.

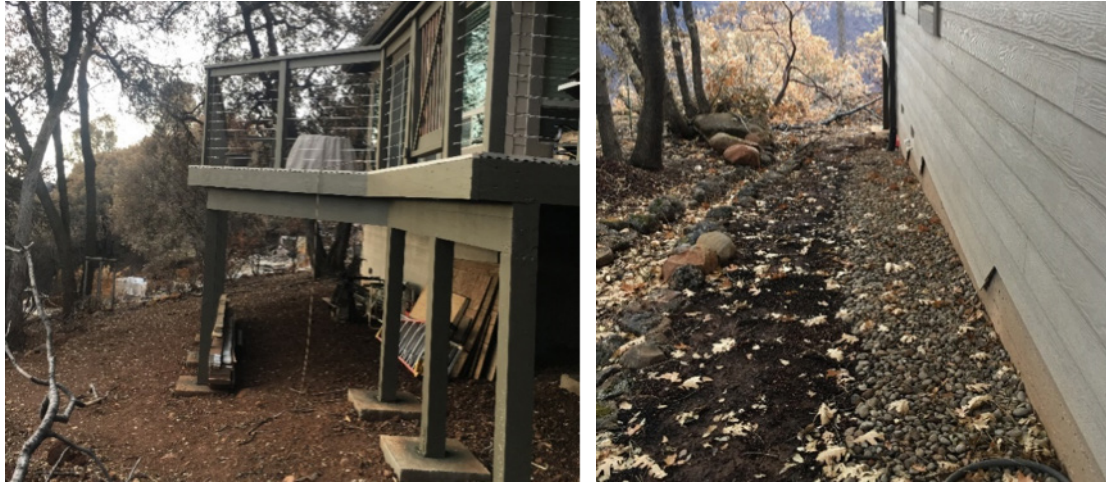
Examination of the home that was not destroyed (see Figure 6) showed that surface fuels around the home are limited, including underneath the deck and the 5-foot noncombustible zone around the building. (The homeowners stated that visible items were placed there after the fire.) The home was built after 2008 and conforms to the Chapter 7A requirements. In addition, the homeowners created a noncombustible zone around the building with rock gravel and vegetative fuel on the down-slope that is well managed. This reduced the potential direct flame contact underneath the deck. In this case, mitigation strategies were effective when low to medium thermal exposure conditions were encountered.

Figure 6. Combination of recommendations and less intense exposure. Well-maintained defensible space and noncombustible zone (rock mulch) around the building and underneath the deck.

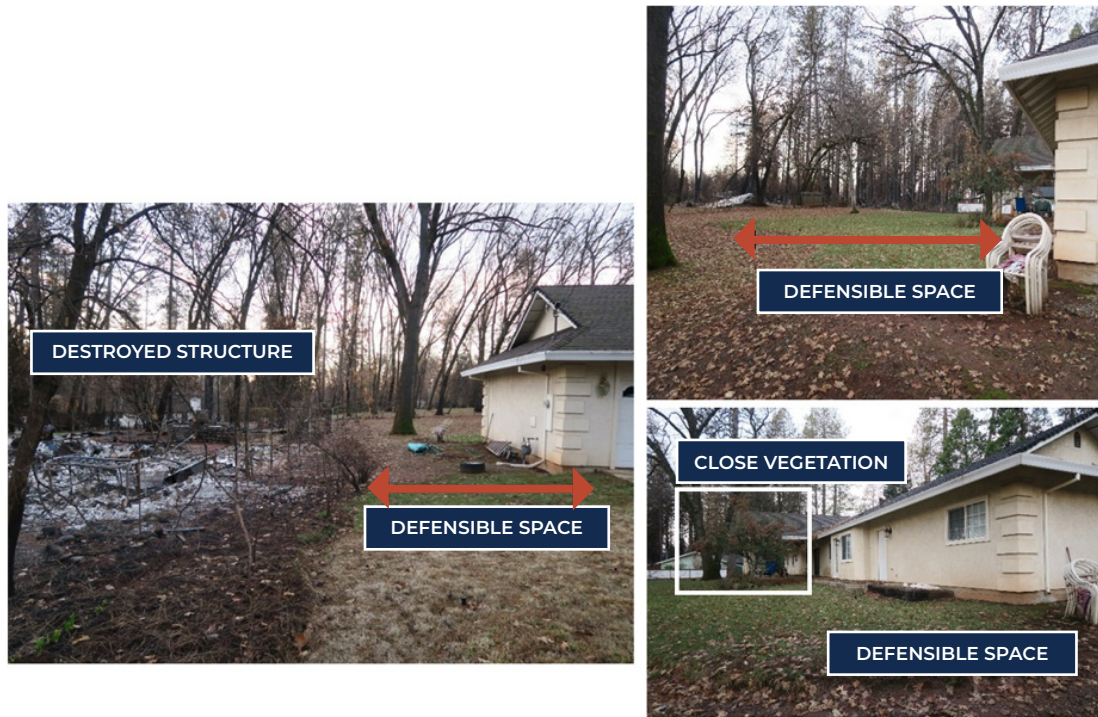
A central part of IBHS guidance to home and business owners is creating and maintaining defensible space around a structure. IBHS research has shown that a key attribute of defensible space is a 5-foot noncombustible zone around a structure.<sup>9</sup> While defensible space does not guarantee a structure's survival, it was found to be an effective mitigation strategy for numerous structures surveyed. Figure 7 shows the backyard of a surviving home. It was clear that fire burned up to the outside edge of their defensible space, 30 ft of well-maintained lawn.

Figure 7. Series of photographs of a home that survived the Camp Fire. The image on the left shows evidence of a nearby structure that was destroyed approximately 20 ft away. The images on the right show in general, well-maintained defensible space except for a tree and large bush near the home (bottom-right image).

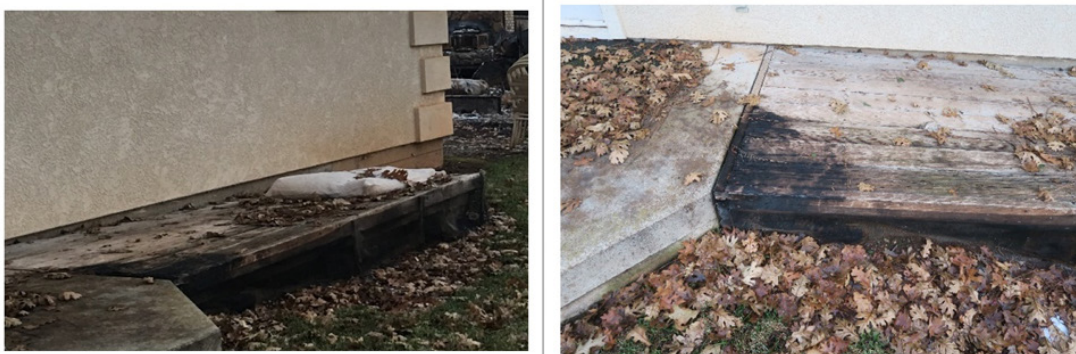
Examining the property in more detail, the corner of the deck on this home is charred, almost certainly due to ember exposure (Figure 8). IBHS has previously observed that embers accumulate in the area between the deck boards and can cause ignition.<sup>10</sup> During the investigation it was also noted that the underdeck area was blocked with mesh screen. The screen would limit the entrance of wind-blown vegetative debris and embers that can accumulate underneath the deck and potentially expose the underside of the deck to flames. IBHS research has shown this type of exposure can often ignite the deck and create a significant risk to the structure.

Figure 8. Charred deck and mesh screen from the same home shown in Figure 7.

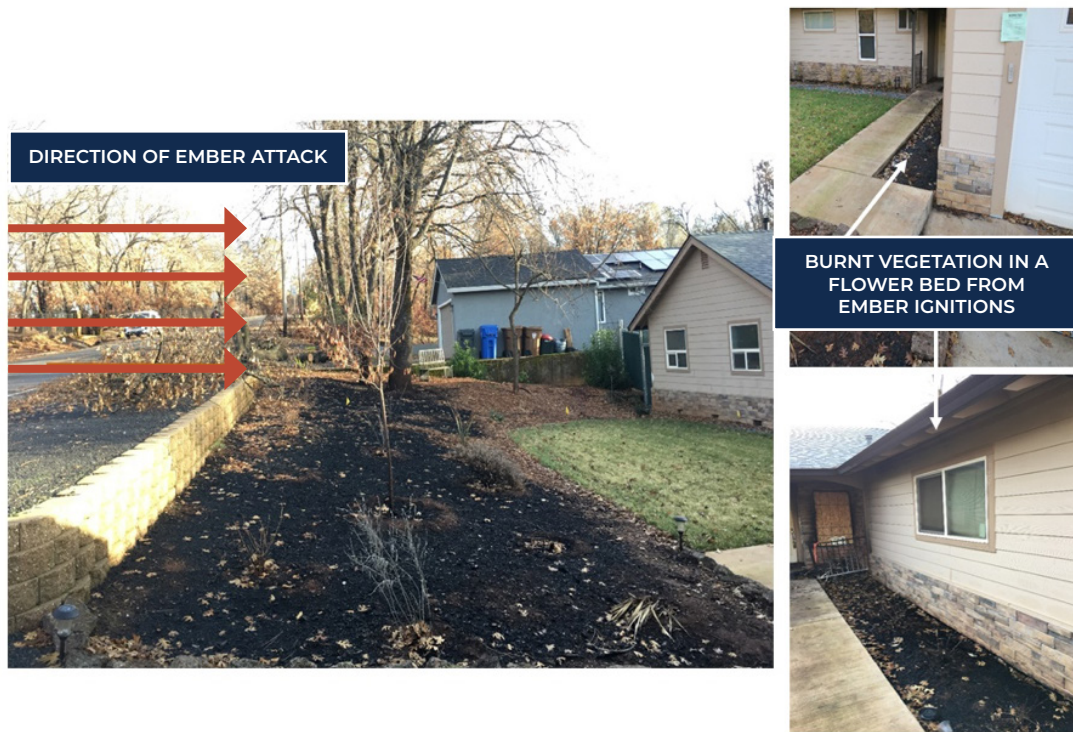
Another example of the effectiveness of fuel management in reducing thermal exposure to a house is shown in Figure 9. The photos were taken on the west side of Paradise on Valley View Drive. Embers lofted from the wildland area (from the left in Figure 9-A), travelled uphill toward the community, and landed on different fuels. The entire area in Figure 9-A acted as the fuel bed for the flying embers. The charred area was more susceptible to the ember attack compared to green grass. However, the available fuels were low density surface fuel with relatively low heat release rate. This caused a reduced exposure to the building.

The photos on the right side of Figure 9 (B and C) depict the same part of the home from different angles. As shown, the immediate zone around the structure is charred from ember-driven ignitions. The ignition of surface fuel in that area exposed the siding on the building to direct flame contact and radiation. The damage was minor due to the relatively low heat release rate of surface fuels and noncombustible siding on the building. The other side of the building (a garage door, not shown) received a similar ember exposure, but due to a quality noncombustible zone, is intact.

Figure 9. Effectiveness of vegetative fuel management around the house up to property line.

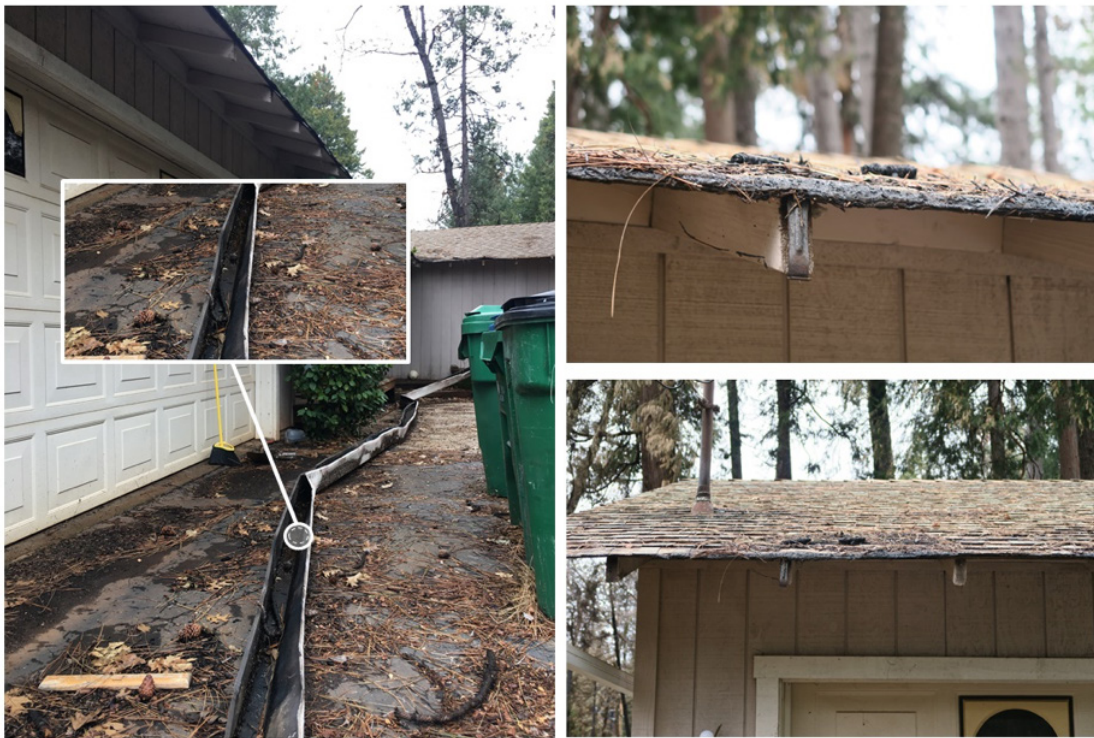
Figure 10 shows a home in the Magnolia community north of Paradise where the gutter had been pulled from the house by first responders and was lying on the ground. Further inspection indicated that there had been burning debris in the gutter, likely ignited by an accumulation of embers, and minor burn damage was observed on the edge of the roof where the gutter had been attached. This has been seen in previous fires and is an intervention by firefighters where if they see flames in a gutter, they quickly pull it to the ground to prevent ignition of the building.<sup>11</sup>

Figure 10. Examples of vulnerability of gutter to ember exposure in the Magnolia community after the Camp Fire.

While it is not possible to know definitively, it is likely the two structures in Figure 10 and Figure 12 would have been destroyed without firefighter intervention. The scale of the Camp Fire and the limited first responder resources in the area would suggest that these houses survived somewhat by random chance. That is, first responders happened to be driving past at a time close to ignition and were able to take quick and decisive action. However, an important point in both cases is that the risk to the structure can be evaluated and could have been reduced. Had appropriate mitigation steps been taken, their survival would not have been dependent on a random encounter and intervention by first responders.

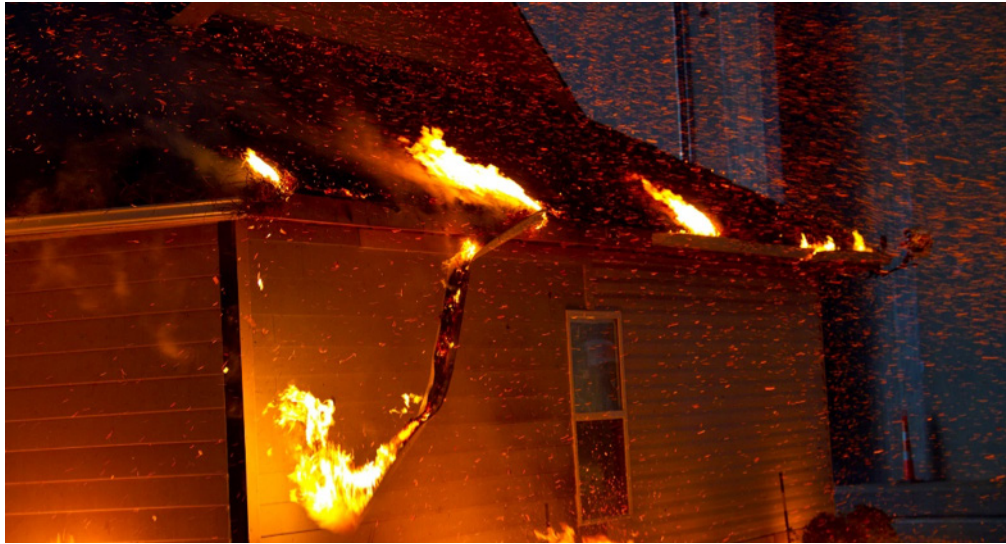
Gutters often accumulate combustible debris (for example, pine needles) if they are not properly maintained. IBHS has shown the tendency of accumulated debris in gutters to ignite due to wind-blown embers. As shown in Figure 11 (next page), the burning debris in the gutter creates a direct flame contact exposure to the edge of the roof and illustrates how non-metal gutters can detach, carrying fire to the base of the building.

Figure 11. Gutters on fire and melting during an ember attack demonstration in the IBHS large test chamber.

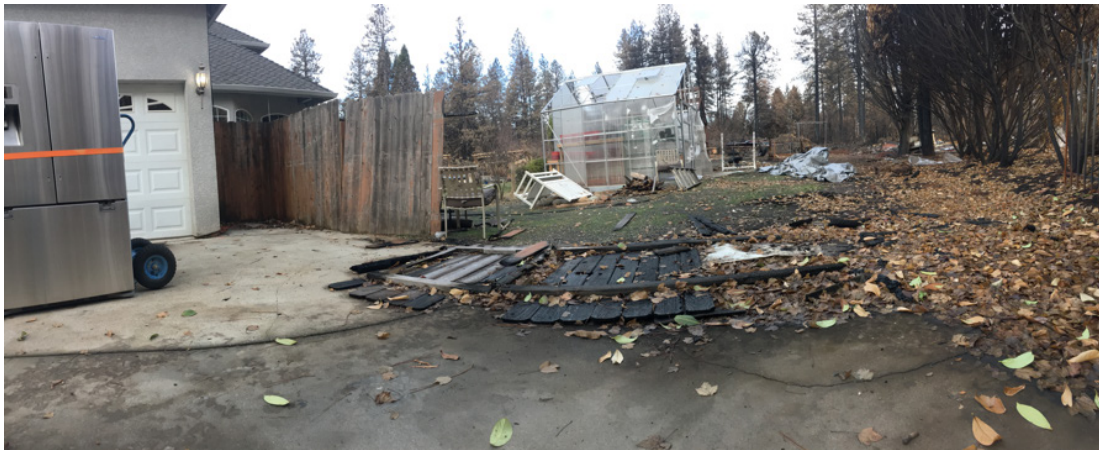
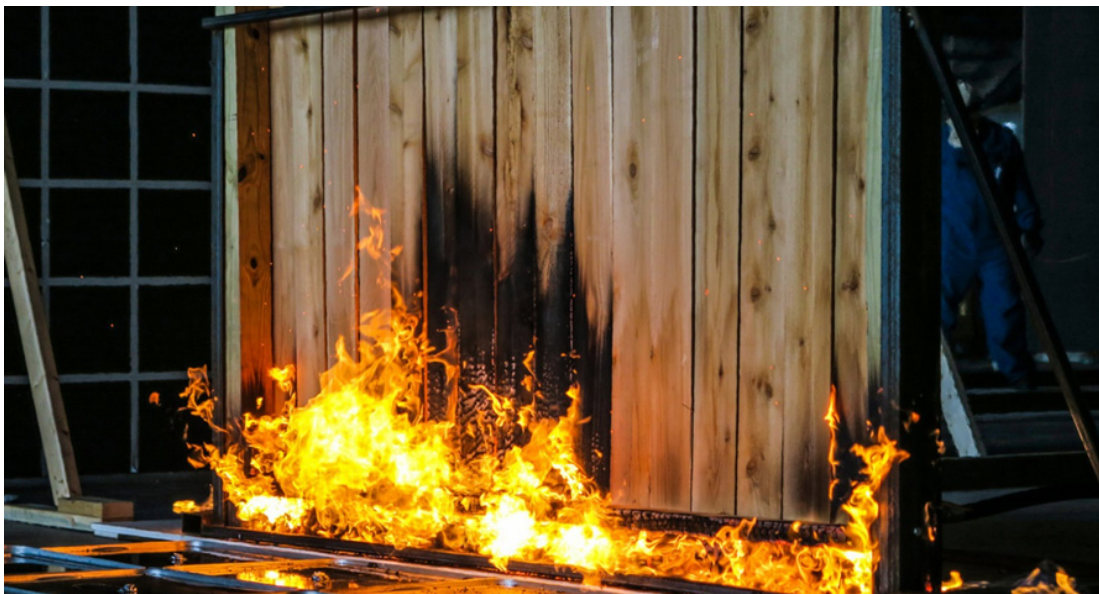
Figure 12 (top) shows a scene observed at many homes where a wooden fence showing signs of burning was knocked down to the ground. Similar to the observed gutter fire intervention, this is likely the result of emergency responders doing emergency mitigation to prevent structure ignition. IBHS testing has repeatedly demonstrated that fences can provide a pathway for fire spread to the building (Figure 12 - bottom).

Figure 12. Top: Fence with evidence of burning that was knocked down. Bottom: a similar combustible wood fence during testing at the IBHS Research Center.

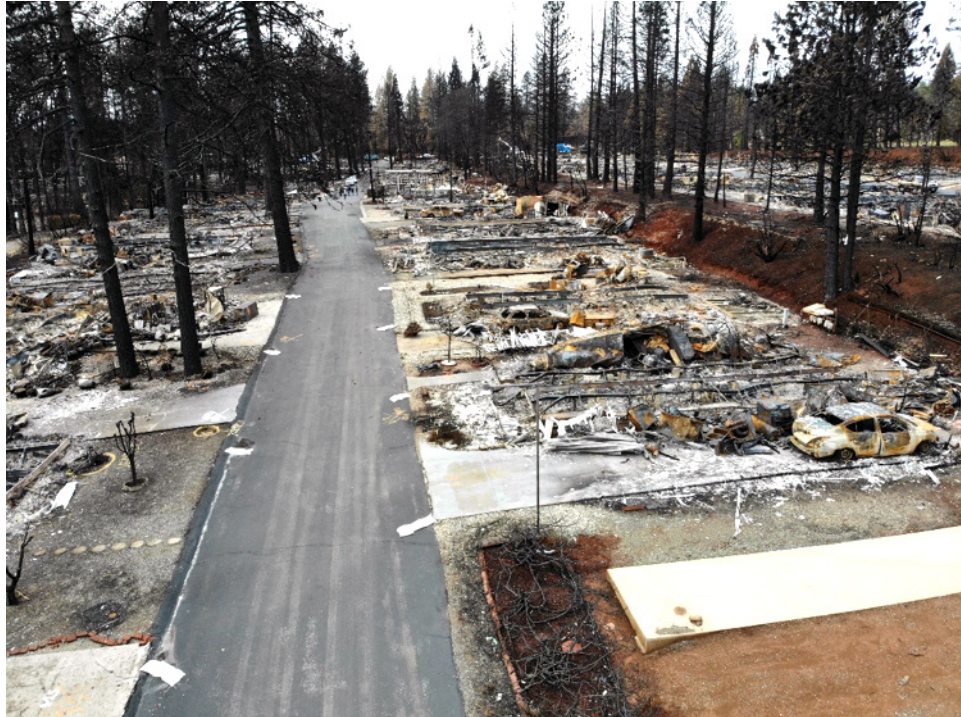
Similar to other fires in 2017 and 2018, several Paradise neighborhoods showed evidence of building-to-building fire spread. Building-to-building fire spread is a known challenge to resiliency for wildland-urban fires. To maximize use of available land, communities are often densely packed with minimal home separation. Examples include Coffey Park (Tubbs Fire, 2017) and manufactured-home communities in Paradise (Figure 13). In wildfire conditions with high winds, fire has the potential to rapidly spread from building to building and this phenomenon is similar to the way fire spreads through continuous vegetative fuels.

Figure 13. Manufactured-home community completely destroyed in Paradise, California. Separation distance between structures was approximately 10 ft.

Building-to-building spacing is a key factor in cascading damage from one burning building to another. This phenomenon needs significantly more attention because there is little research-based guidance available. In 2019, IBHS analyzed measurements taken by the UL Firefighter Safety Research Institute (FSRI) in Dayton, Ohio, during a series of experiments on full-sized homes, including free-burn tests. As a result, IBHS found that a spacing of less than 10 ft posed a significant risk of building-to-building ignition, while separation distances greater than 50 ft posed little risk. The wind speed at the time these experiments were performed was 2–5 mph, which is not representative of a wildfire situation. To provide meaningful and practical guidance on this issue, further research is needed to understand the degree of risk reduction for separation spacings of less than 50 ft.
