IBHS Hailstorm Demonstration Results

Insights on Recreating a Hailstorm

FEBRUARY 2013

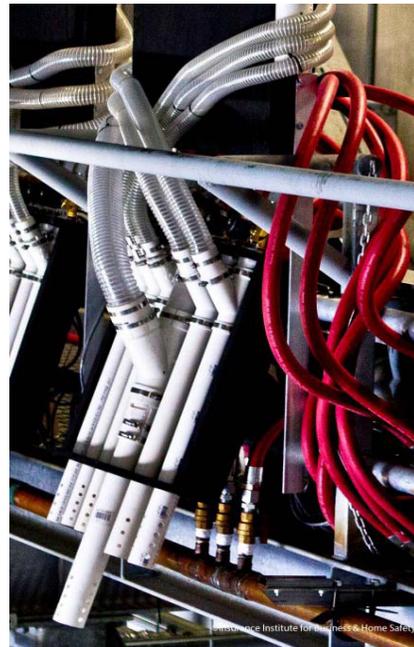
A hail propulsion system is shown attached to the IBHS Research Center catwalk 60 ft. above the test chamber floor. During the demonstration, hail was loaded into 12 cannons, each with six barrels able to deliver variously sized hailstones.

- More than 9,000 hailstones were launched during the test.
- 1-inch hailstones traveled at 51 mph.
- 1.5-inch hailstones traveled at 63 mph.
- 2-inch hailstones traveled at 76 mph.
- The propulsion system, which used an automated control system to ensure proper distribution of variously sized hailstones across the storm field, included 12 cannons, each with six barrels.

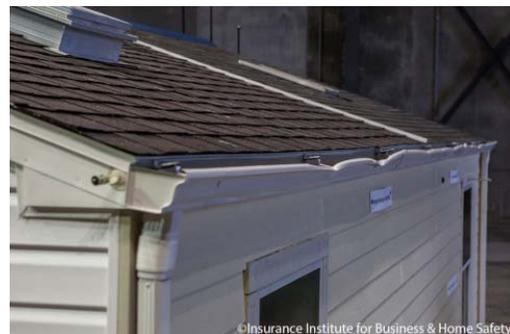
Damage to the test specimen's aluminum gutters.

- Numerous large dents were observed on the gutters, decreasing their effectiveness, and (in the real world) reducing curb appeal.

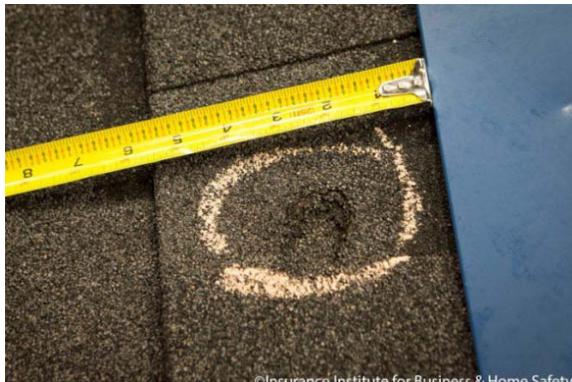
An impact is shown on one of the test specimen's impact-resistant laminate shingles. The majority of impacts on these shingles were only cosmetic.

- Impact-resistant shingles: the majority of impacts were cosmetic. A few impacts did puncture the shingles, causing functional damage.
- 3-tab shingles: the majority of the impacts were severe enough to be considered functional, rather than cosmetic, damage. A few cosmetic marks also were observed.
- Opportunity for further study: The cosmetic impact marks should be monitored to determine if they will lead to further shingle degradation, which would reduce the life of the roof and increase vulnerability to water entry.

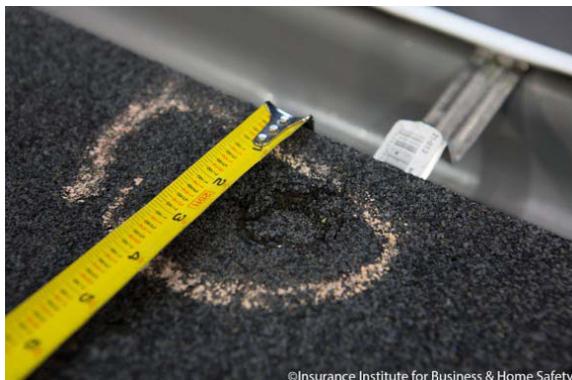
Damage is shown to a 3-tab shingle on the test specimen. The majority of impacts on these shingles were severe enough to be considered functional damage.

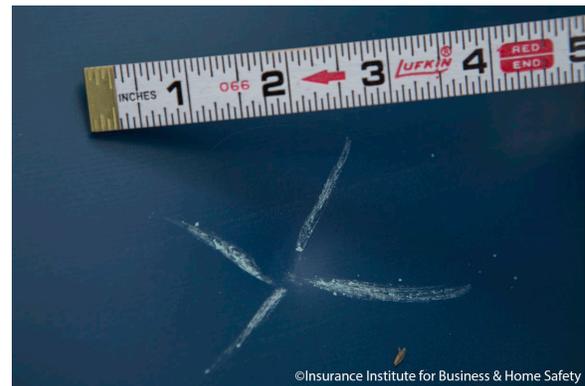
Although the damage to the test specimen's metal roof shown above is clearly visible, it was only cosmetic in nature.

- Damage to both sections of metal roofing was cosmetic in nature, leaving visible dents but no punctures.
- Standard installation of metal over roof deck: dents were smaller and shallower.
- Metal installed over shingles: dents were larger and deeper.
