# IBHS Roof Aging Program

Data and Condition Summary for 2015

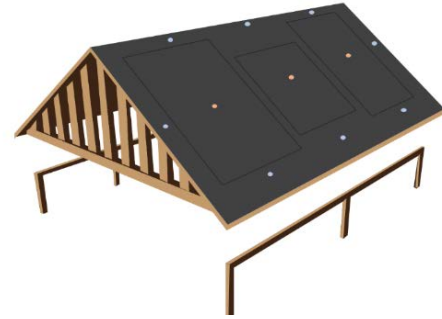
*Figure 1-1. Diagram of a roof specimen showing temperature probe measurement locations. Note that for specimens at the Madison (Wisconsin) and Amelia (Ohio) sites, temperature probes are located on the center panel of each roof face only.*

- Each specimen structure (Figure 1-1) is a gable roof, 6/12 slope, with code-required ventilation, and is nominally 15 ft x 15 ft. The roof is enclosed on the sides and bottom to create an enclosed ventilated “attic.”
- Roof products were selected based on type, manufacturer, market prevalence, and published standard test ratings.
- Each specimen features six removable panels—three north-facing panels and three south-facing panels:
  - Two each: 55- x 66-in. panels for use in ASTM D3161 and ASTM D7158 high wind tests, and FM 4473 and IBHS impact tests.
  - One each: 36- x 36-in. panel for use in UL 2218 impact tests.
  - Excess shingles around the panels will be used for materials testing.

The specimens at the IBHS Research Center are instrumented with multiple temperature sensors (Type K thermocouples) on each roof face. For each embedded test panel, temperature sensors are located in the center of the panel between shingle courses to measure the shingle temperature, and between the underlayment and roof deck (2013 specimens also have sensors located between the shingles and the underlayment). In addition to the test panel temperature sensors, the 20-year IBHS specimens have an array of sensors across the entire roof face. Temperature and relative humidity measurements are made in the attic space of select IBHS specimens. At the Amelia and Madison sites, shingle and roof deck temperature measurements are made on the center panel of each roof face. For more detailed information on the specimen design and instrumentation, please see the detailed technical report completed in 2015 at [DisasterSafety.org/wp-content/uploads/2015/12/aging-farm-climate-summary-2015\\_ibhs.pdf](https://DisasterSafety.org/wp-content/uploads/2015/12/aging-farm-climate-summary-2015_ibhs.pdf).
