IBHS Roof Aging Program

2016 Data, Climate, and Roof Condition Summary

NOVEMBER 2017

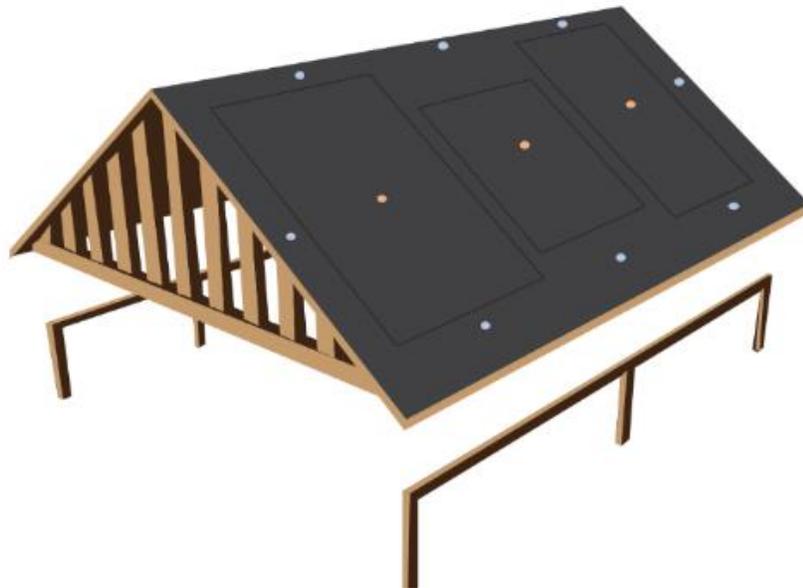
Figure 1-1. Diagram of a roof specimen showing temperature probe measurement locations. Note that for specimens at the Madison, Wisconsin, and Amelia, Ohio, sites, temperature probes are located on the center panel of each roof face only.

All roofs included in this program are identical in construction, oriented in the same direction (north-south exposure), and similar in color. The variables—including product type, length of exposure, and climate—will be examined to understand how they contribute to performance differences.
