Wildfire Research

Performance of Fire-Retardant Coatings Used in Exterior Applications

Stephen L. Quarles, Ph.D.
Christine D. Standohar-Alfano, Ph.D.

OCTOBER 2017

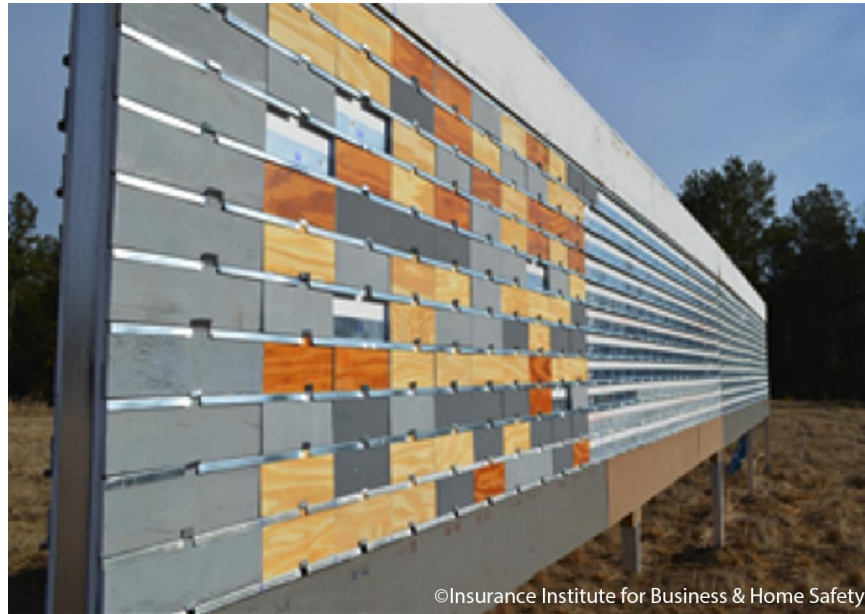
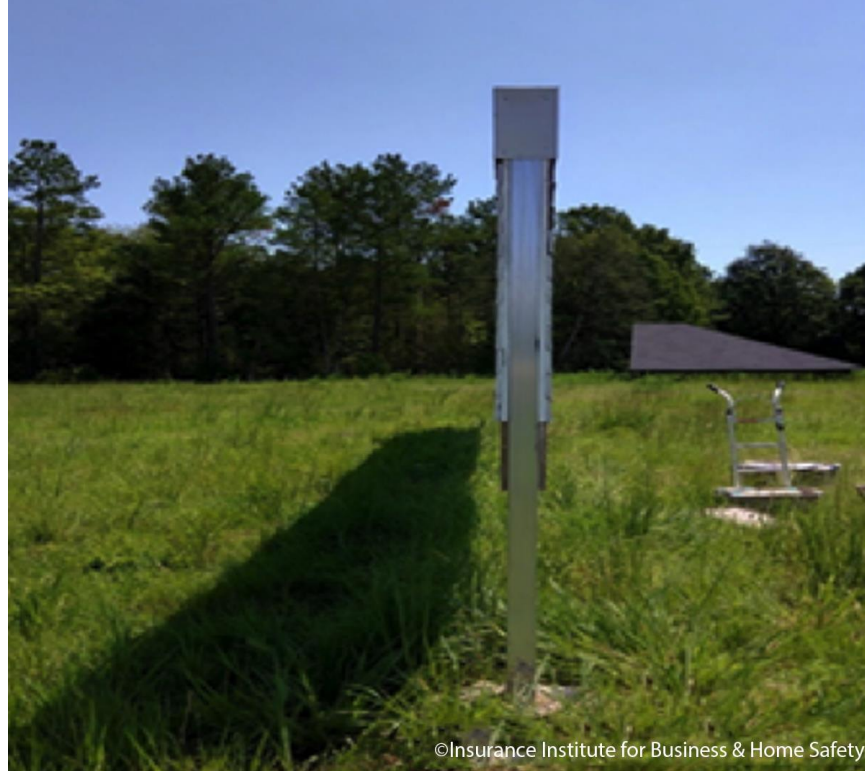
Figure 2. Specimens on the weathering fence (top), and the weathering fence at noon (bottom) with northern exposure on the left and southern exposure on the right (Bahrani, 2015).

The specimens to be weathered were placed on an aluminum fence located at the IBHS Research Center. The capacity of the test fence was 1,232 specimens. Half of the specimens were placed on the north-facing side and the other half were placed on the south-facing side. Photographs and diagrams of the fence are shown in Figure 2. In addition to a control specimen (0 months and no weathering), each coating had

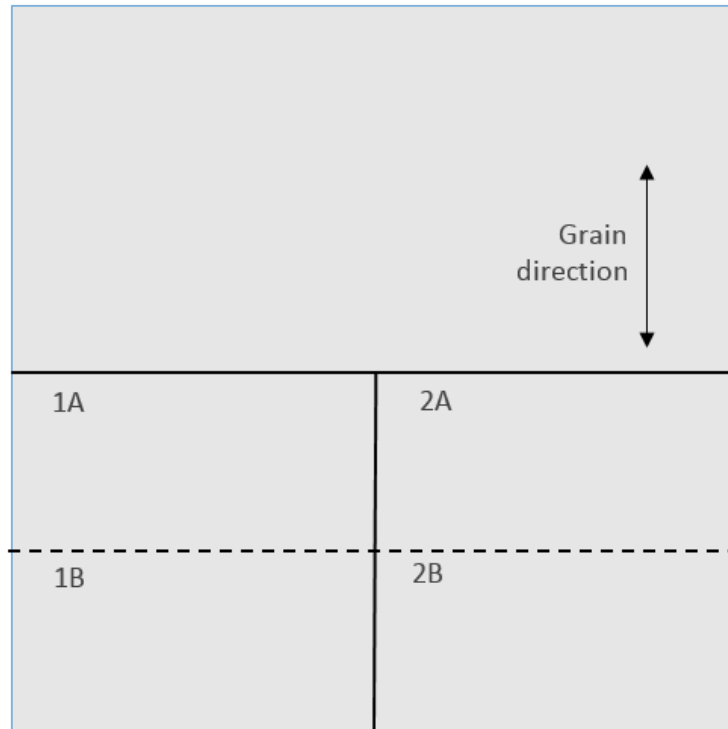
Figure 4. Specimen preparation for measuring film thickness.

To evaluate the influence of paint film thickness on fire performance, thickness was measured before weathering and after each weathering period. Penetrants D and E were not included as they did not form a film. The natural color of the penetrants also made it difficult to measure penetration depth. For Coatings A, B, and C, the paint film thickness was measured following the guidelines provided in ASTM D5235-14 (2014). Each of the selected 4-in. x 4-in. (100-mm x 100-mm) specimens was cut into two 2-in. x 4-in. (50-mm x 100-mm) pieces. One piece was saved for future evaluation and the other was further cut into four equally sized pieces measuring 1-in. x 2-in. (25-mm x 50-mm). Refer to Figure 4. These pieces were labeled 1A, 1B, 2A, and 2B. The 1A and 1B pieces were face-glued together, using a clear hot-melt adhesive, to create a 1-in. x 2-in. block with a thickness that was twice the panel thickness. The same procedure was followed for the 2A and 2B pieces. This procedure resulted in two samples that were used to determine paint film thickness.

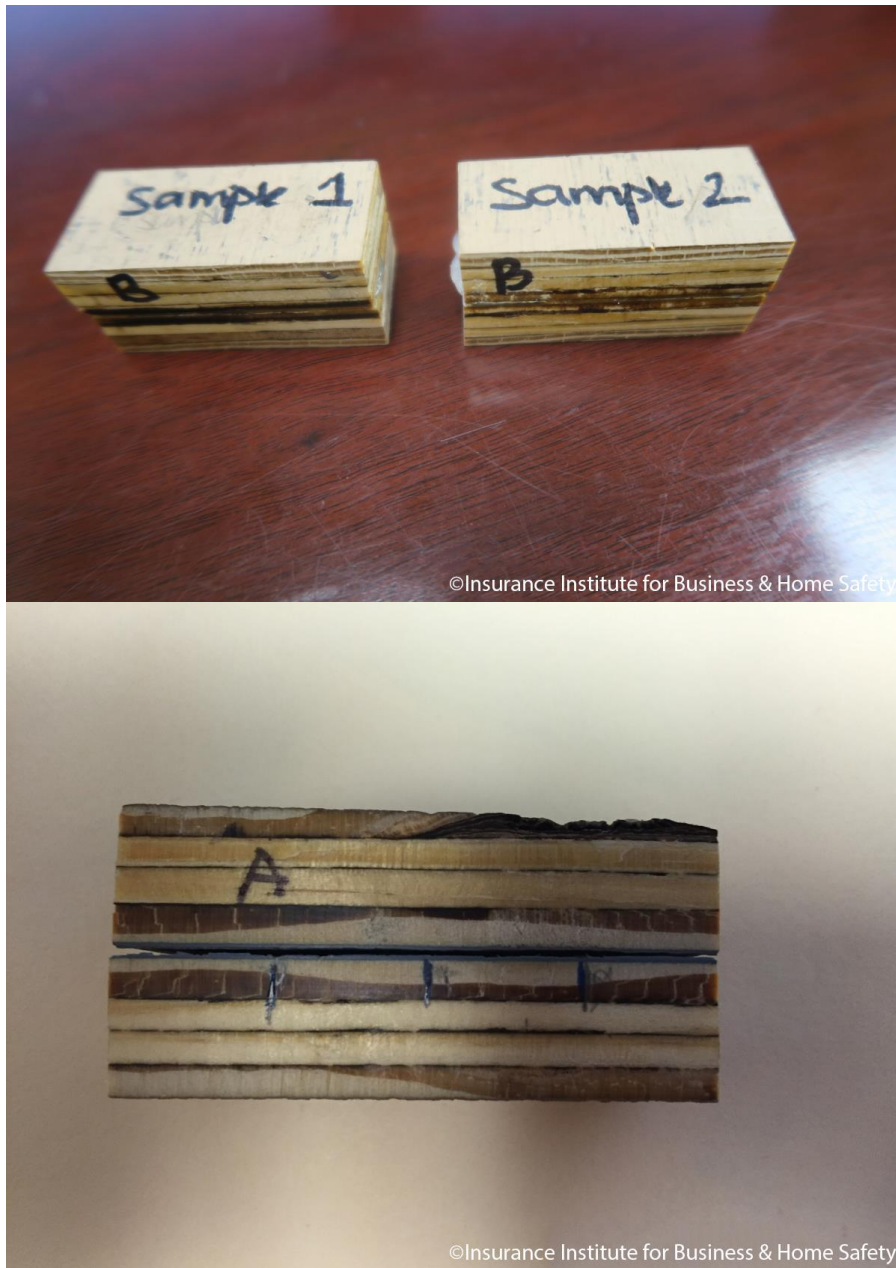
Figure 5. Prepared samples (top) with sanded edges (B side shown), and sample (bottom) divided into four sections (A side shown) for measuring paint film thickness.

Once the pieces were face-glued together, the surfaces of the samples were prepared for measurement of paint film thickness as specified in ASTM D5235-14 (2014). Both long edges of the samples were sanded using a 200-grit sandpaper. To finish preparation, the samples were sanded again using a 600-grit sandpaper. Each long edge was then divided into four 0.5-in. (12.5-mm) sections for measurement as shown in Figure 5. Each of the samples selected for thickness measurements were prepared in this manner.

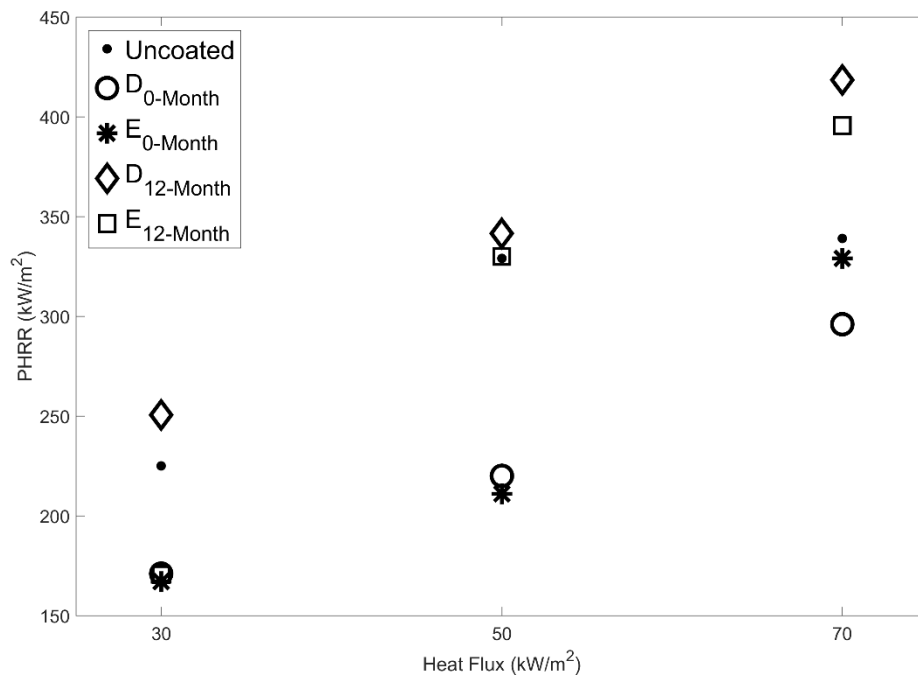
Figure 22. PHRR data for Coatings D and E after 0- and 12-month weathering periods. Results for the uncoated and non-weathered control are also shown.

For the penetrant coatings, cone calorimeter data was analyzed for the 0- (control) and 12-month weathering periods. TTI and PHRR results are shown in Figures 21 and 22, respectively. The plotted data shows averages of measurements taken for north and south oriented specimens. Differences in performance for TTI decreased with increased exposure levels. At the 30 kW/m² radiant heat exposure level, the uncoated and non-weathered specimen performed better than the coated specimens (i.e., the TTI was longer). Differences in performance as a function of weathering and coating were not apparent at the 50 and 70 kW/m² exposure levels.

Results of the PHRR data for Coatings D and E were similar in that the uncoated, non-weathered specimen result was typically between the coated, weathered specimen results. At the 50 and 70 kW/m² heat exposure levels, weathering resulted in a higher PHRR for the penetrant products. Results for the penetrant with non-intumescent characteristics were like those for the intumescent product. Because of the poor performance of the penetrant products, particularly when considering TTI, additional testing was not conducted.
