Hurricane Harvey Wind Damage Investigation

Insurance Institute for Business & Home Safety

JULY 2018

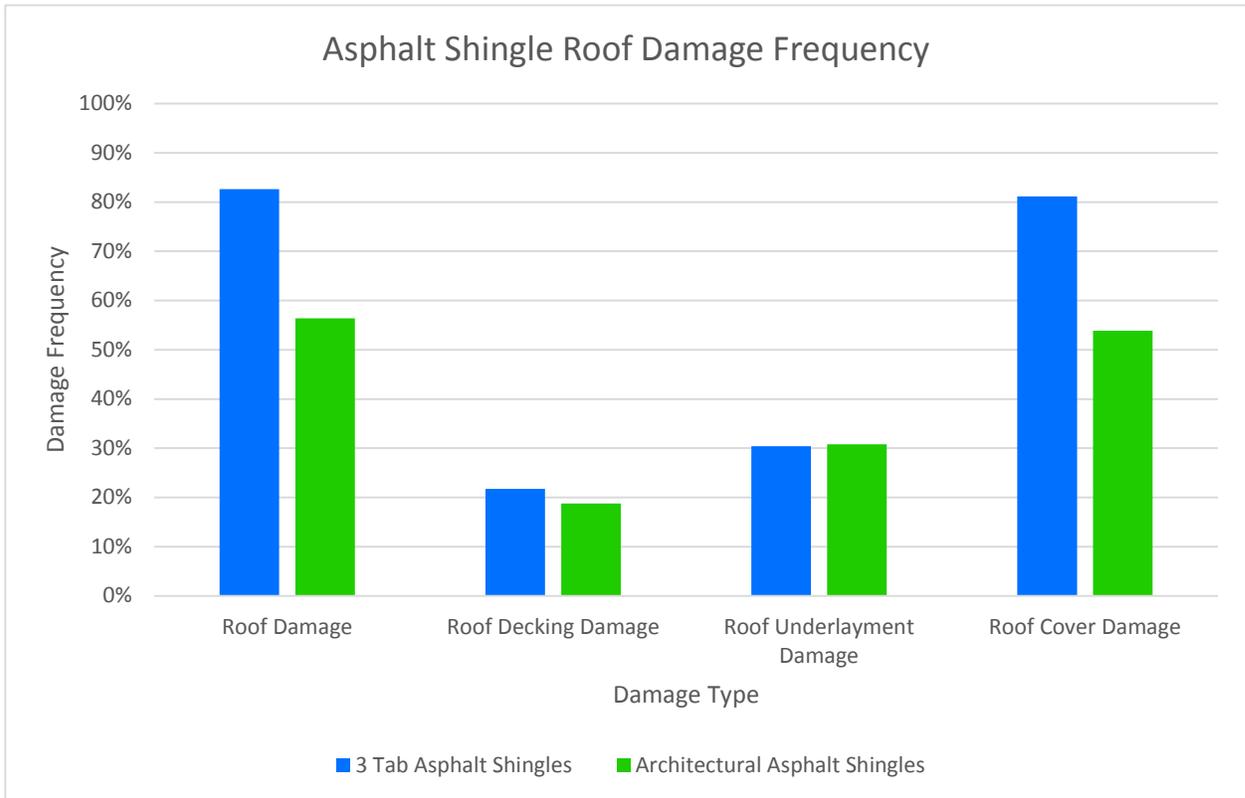
- More than 85% of the roof covers investigated were asphalt shingle roofs, with no quantities greater than 5% for other roof cover types.
- For the shingle roofs, Figure 3 shows:
 - More than half of the shingle roofs surveyed had some roof damage and cover loss.
 - 3-tab shingle roofs had higher damage frequencies than architectural shingle roofs.
- This could be due to the age of the buildings, as architectural asphalt shingles have become more popular in recent years (Roofing Contractor 2018). However, 3-tab shingles have also been found to have higher damage rates compared to architectural shingles of the same age (Dixon et al., 2014).

- The roof cover damage rate for each shingle type is nearly identical to the overall roof damage rate, which means that if a roof displayed damage, it nearly always had roof cover damage.
- The frequency of underlayment and roof decking damage did not seem to be influenced by shingle type, and was much lower than the rate of shingle damage.

Figure 3. Distribution of damage frequency to roof system components by asphalt shingle type.

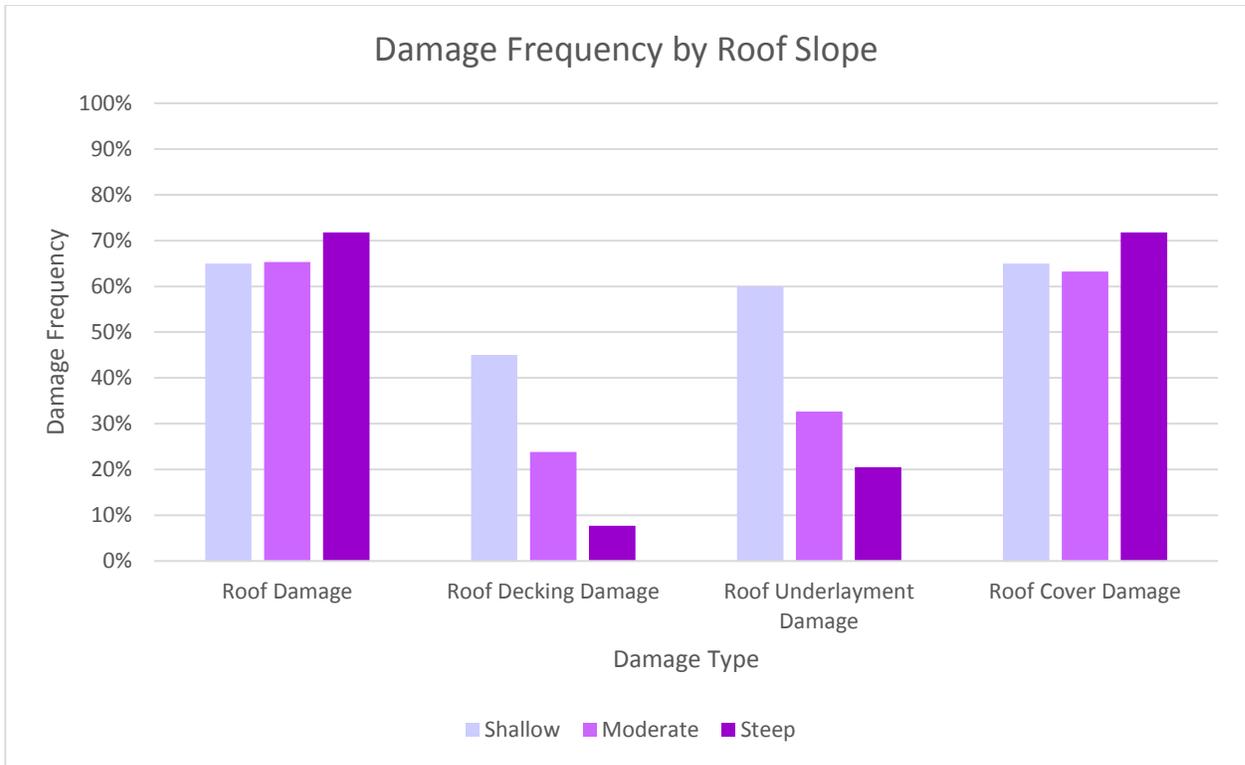
- For all roofs evaluated (all roof cover types), Figure 4 shows:
 - Roof cover damage was generally consistent among the roof slope categories, ranging from 63%–72%.
 - Roof decking and underlayment damage were influenced by roof slope. Steep-slope roofs had the lowest percentage of roof underlayment or decking damage observed. Low-slope roofs had the highest percentage of roof underlayment or decking damage.

Figure 4. Distribution of damage frequency to roof system components by roof slope.

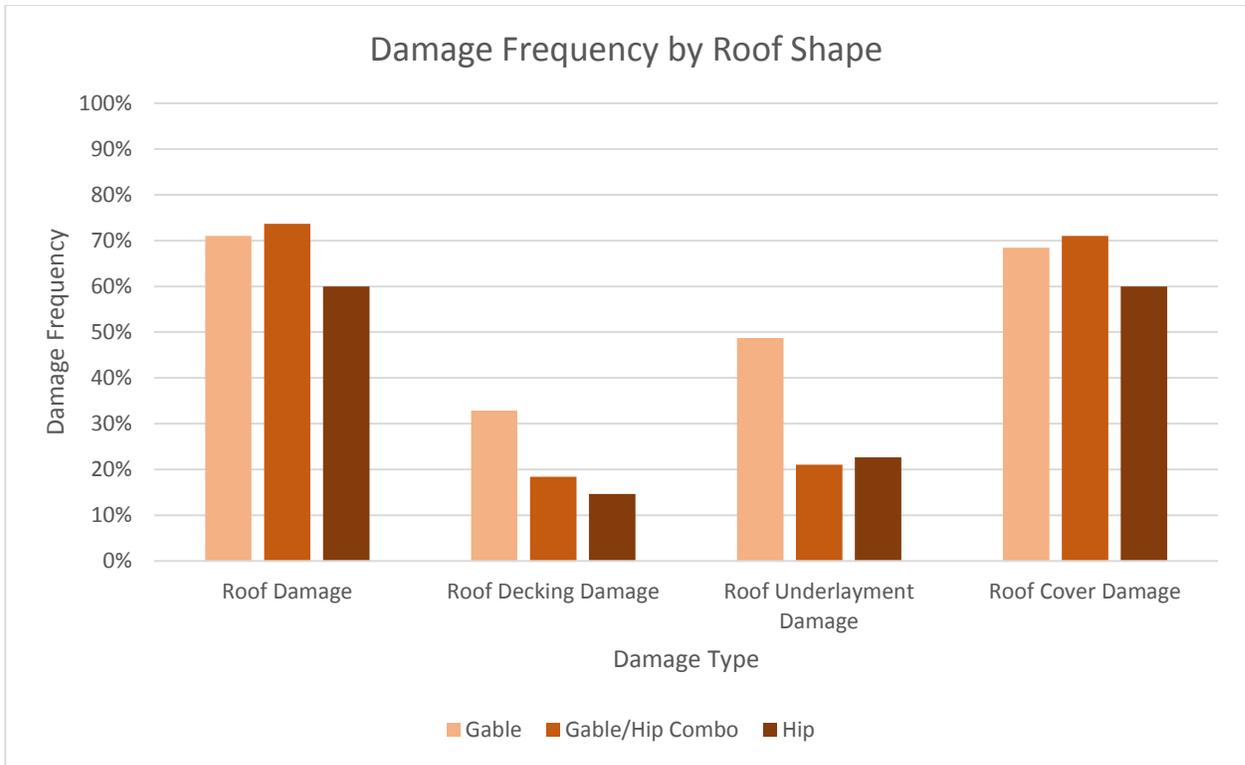
- Most of the roofs assessed were gable, hip, or gable/hip combination roofs. Other shapes did not constitute a large enough sample size to do adequate performance comparisons.
- Other studies have found that hip roofs are typically more resistant to wind damage than gable roofs (Meecham et al., 1991; Meecham, 1992; Kopp et al., 2016; Gavanski and Kopp, 2017; Stevenson et al., 2018).
- For all roof cover types evaluated, Figure 5 shows:
 - Roof shape did not cause much variation in roof cover damage, with damage ranging between 60%–71%.
 - Gable roofs had higher rates of roof underlayment and decking damage compared to hip and combination roof shapes.

Figure 5. Distribution of damage frequency to roof system components by roof shape.

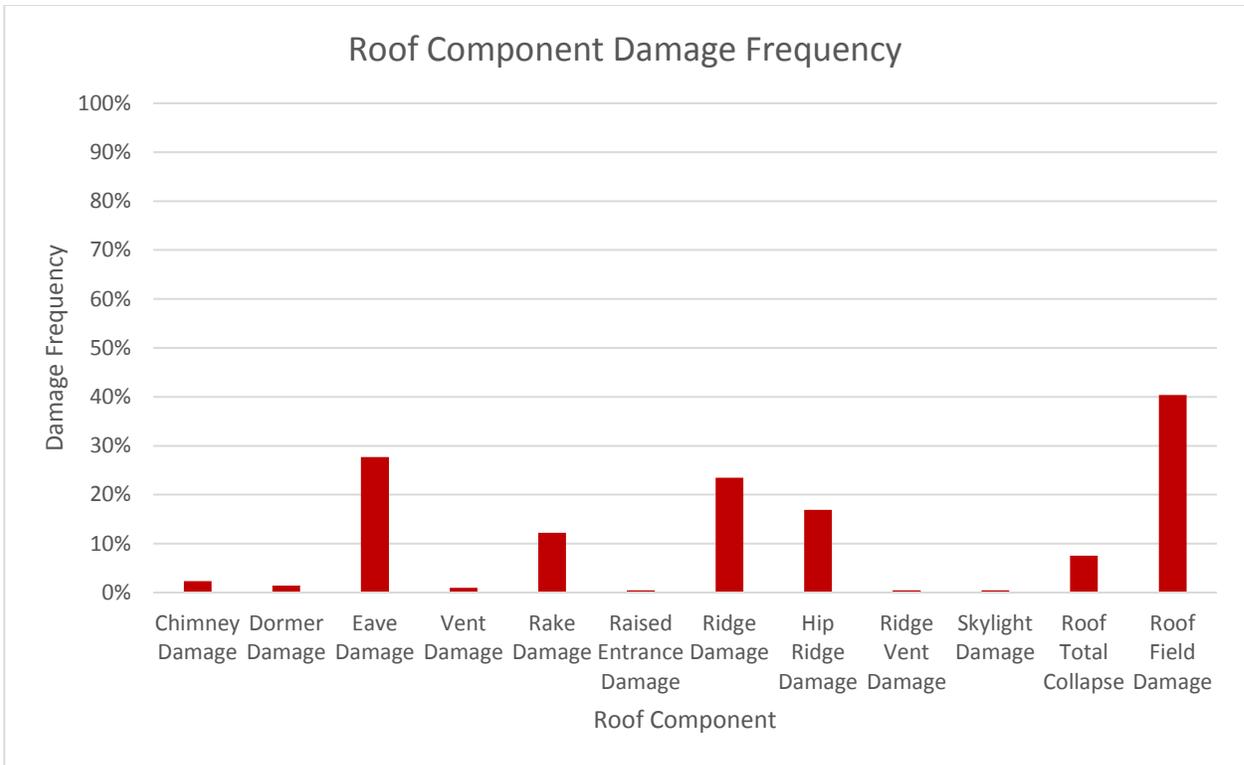
- The majority of visible damage was associated with damage to the roof covering in the field, eave, or rake edge.
- Damage rates were also higher for ridge and hip ridges.
- Total roof collapse occurred for less than 10% of the buildings surveyed.

- Damage rates for roof accessories such as vents and skylights were low.

Figure 6. Distribution of damage frequency to roof system components.

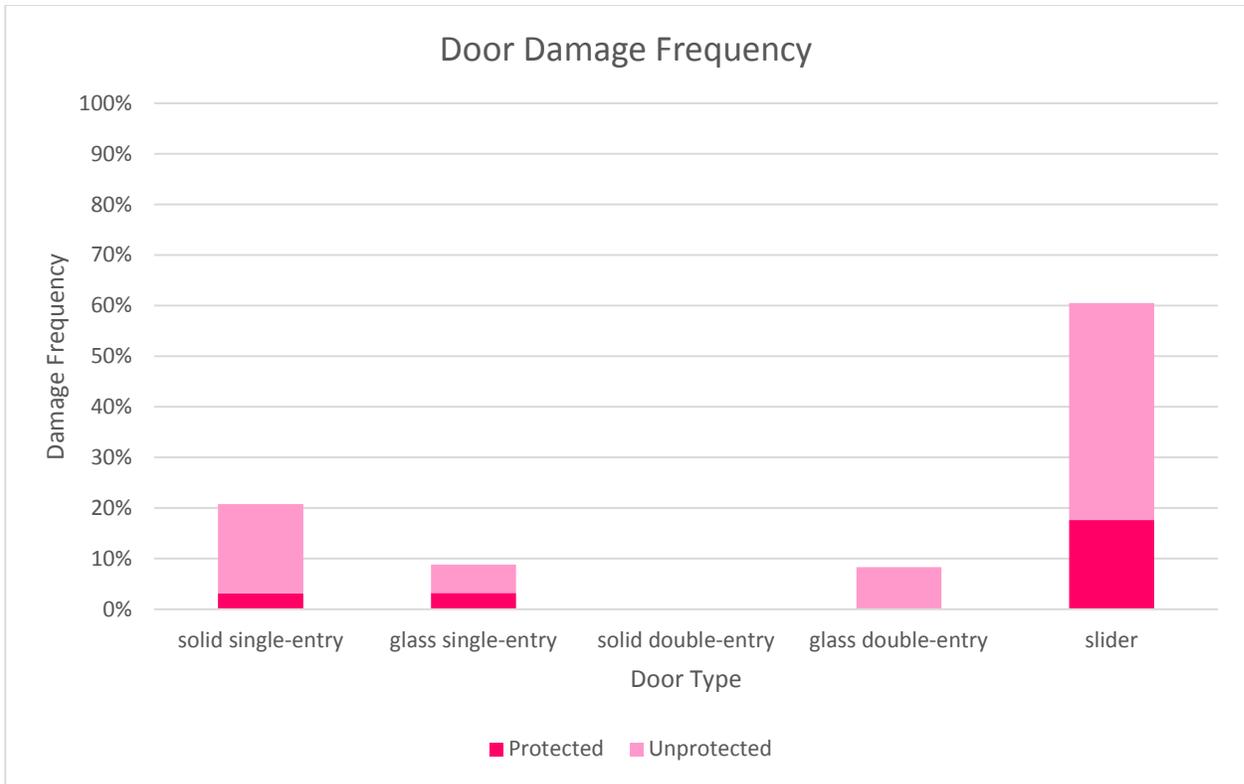
- Unprotected doors were damaged two to six times more often than protected doors
- Slider doors had the highest incidence of damage for both protected and unprotected doors

Figure 7. Distribution of damage frequency by door type and whether it was a protected opening, or unprotected.

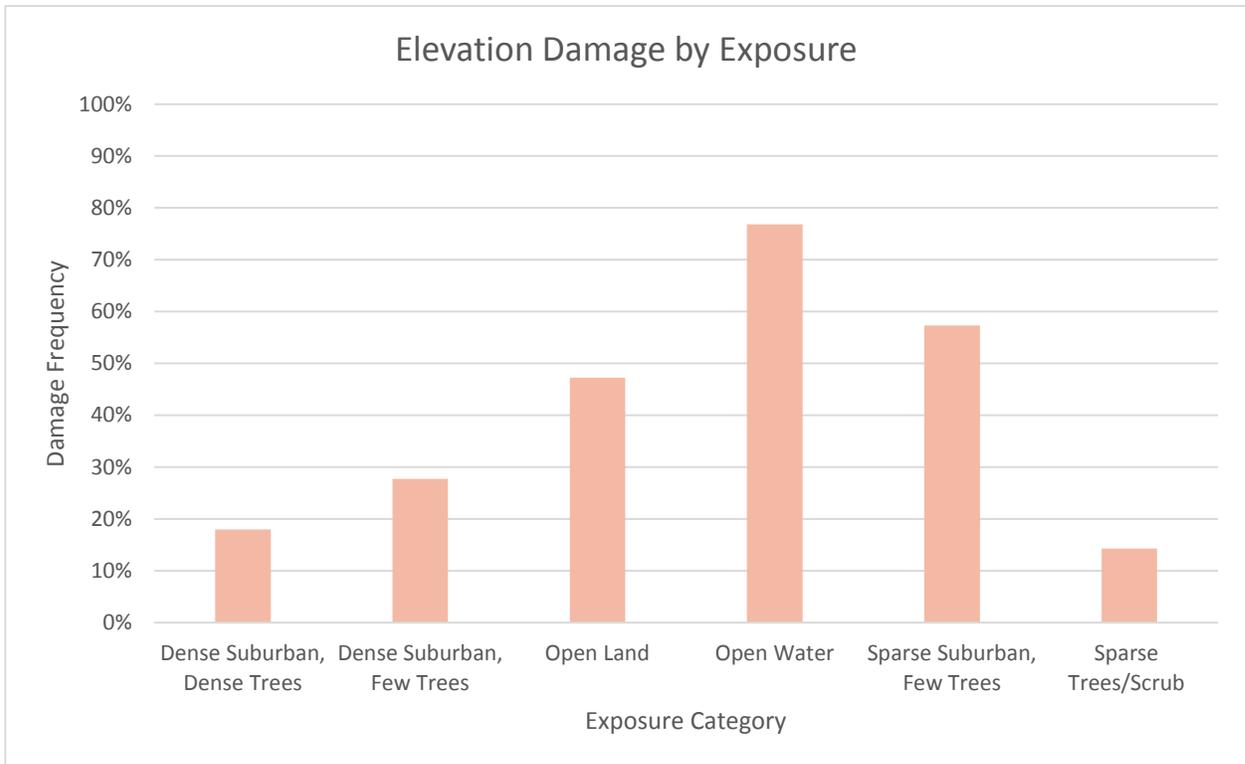
- Elevations with the least amount of roughness or obstructions to slow the wind, such as open water and open land, had the highest rate of observable damage.
- Elevations with higher roughness, such as dense suburban with dense trees, had the lowest observable damage rates.

Figure 9. Distribution of damage frequency of individual elevations by exposure.

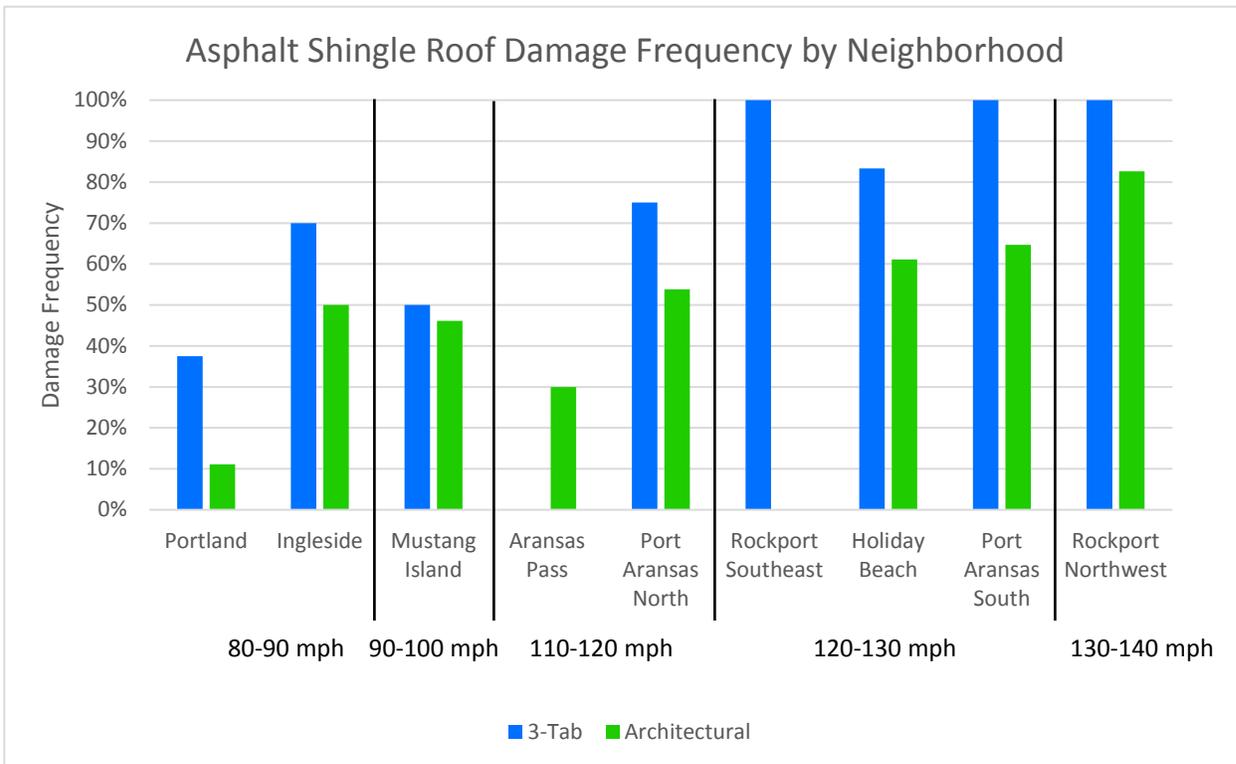
- Holiday Beach, one of the most severely damaged zones overall, had a lower roof cover damage frequency than Rockport Southeast and Port Aransas South.
- Both Rockport Southeast and Port Aransas South had little to no structural damage and were in the same wind speed region as Holiday Beach.
- Homes in Ingleside, with estimated 3-second gust wind speeds of 80–90 mph, had roof cover damage frequencies (50%–70%) similar to those in some areas that experienced 110 mph or greater wind speeds, such as Holiday Beach (61%–83%) and Port Aransas North (54%–75%).

Figure 11. Distribution of roof damage frequency of asphalt shingle roofs by wind speed zone.

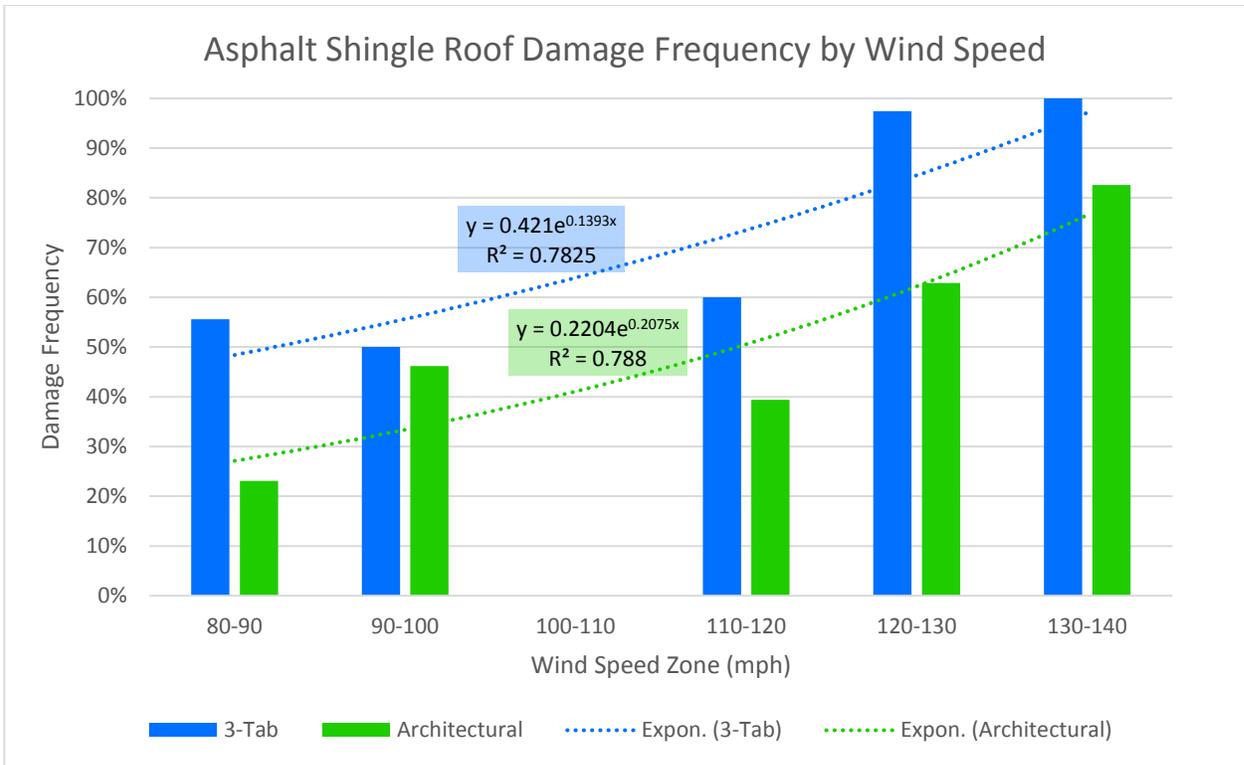
- Roof damage frequency generally increased with increasing wind speed and, as expected, 3-tab roofs suffered the most damage. Vulnerability curves for both shingle types (Figure 12) provide relatively strong fits to the data as shown by the high R^2 values (0.78). This means roof cover loss rates are reasonably well-behaved by wind speed, and thus can be modeled relatively well.

Figure 12. Roof cover damage frequencies in neighborhoods with the same wind speed were combined to generate vulnerability curves. Exponential trend lines were fitted to the data and are displayed with R^2 values. No data were collected in the 100–110 mph wind speed zone.

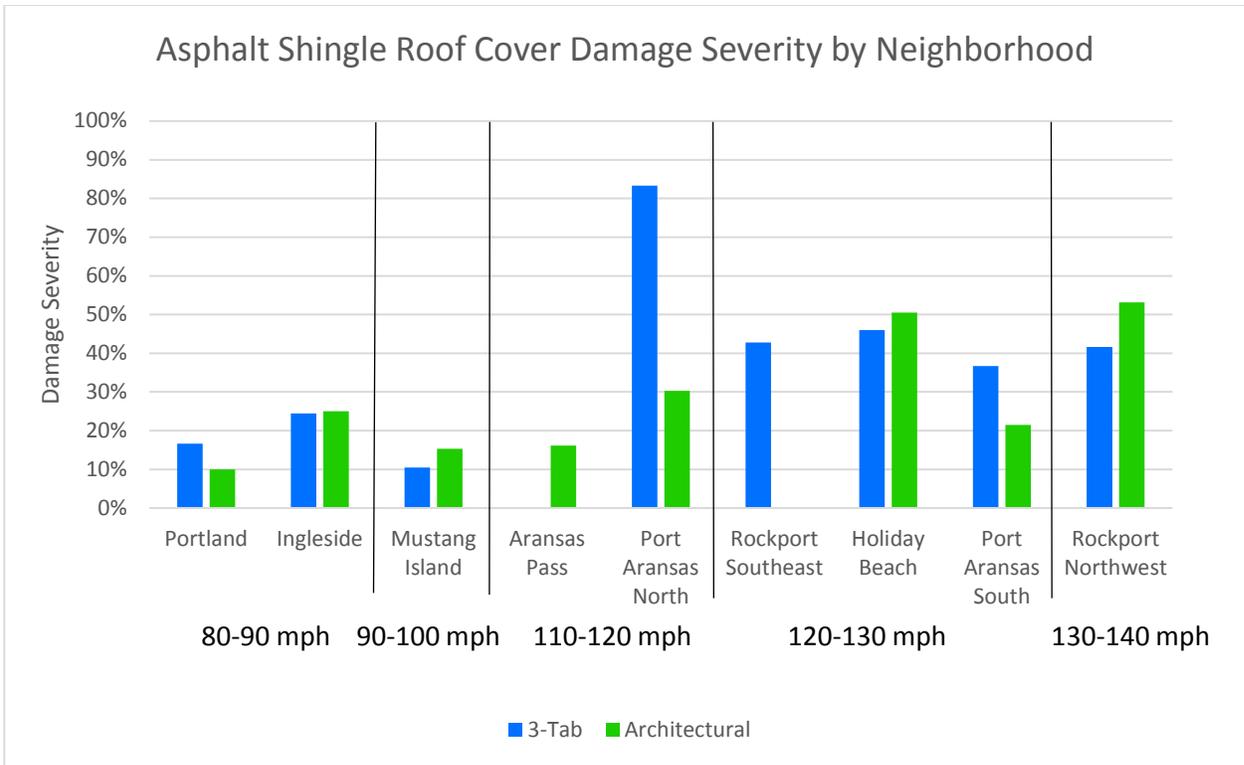
- The roof cover damage severity in Port Aransas South was less than Port Aransas North, especially for 3-tab shingle roofs (37% vs. 83%), despite being less than 2.5 miles apart and Port Aransas South having wind speeds 10 mph higher. The southern neighborhood was typically much newer construction with higher-value homes.

- Roof cover damage severity was approximately the same in Rockport Southeast and Northwest, even though the southeast neighborhood had a much rougher exposure, was located inland, and had wind speeds estimated to be about 10 mph lower.

Figure 15. Distribution of roof cover damage severity of asphalt shingle roofs by wind speed zone.

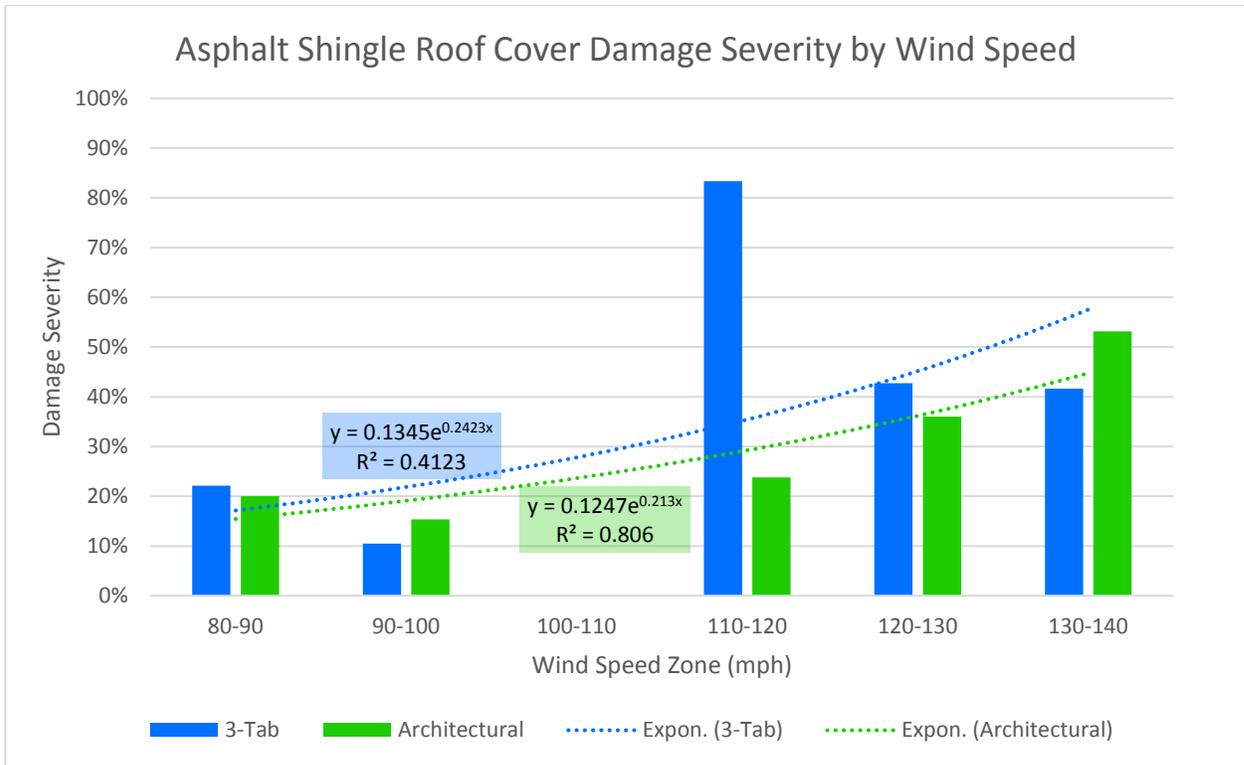
- The high roof cover damage severity for 3-tab roofs in Port Aransas North caused a spike in the damage frequency in the 110–120 mph wind speed zone, which caused a poor fit in the vulnerability curve ($R^2 = 0.41$) in Figure 17.

- The vulnerability curve (Figure 17) fit for architectural shingles is good, with an R^2 value of 0.8, which indicates the damage severity of architectural shingles by wind speed can be modeled well in this dataset.

Figure 17. Asphalt shingle roof cover damage severities in neighborhoods with the same wind speed were combined to generate vulnerability curves. Exponential trend lines were fitted to the data, and are displayed with R^2 values. No data were collected in the 100–110 mph wind speed zone.

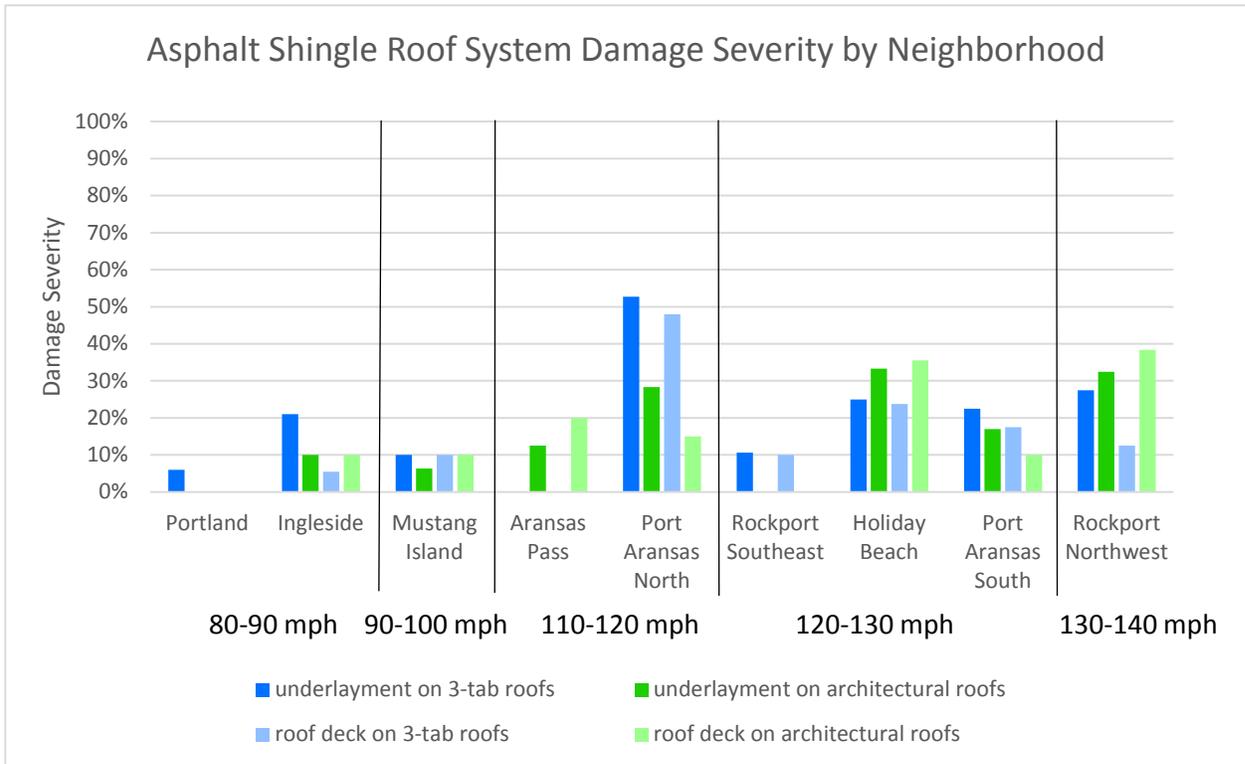
- Although 3-tab shingle damage was most severe for Port Aransas North (Figure 17), Holiday Beach and Rockport Northwest had the most severe structural damage of all areas visited.

- Damage severities for underlayment and roof decking on shingle roofs were generally higher for neighborhoods in the 110 mph wind speed zone or above. However, the highest wind speed zones did not necessarily have the highest levels of damage to underlayment and decking.

- Underlayment and decking damage on shingle roofs was typically highest in Holiday Beach, Port Aransas North and Rockport Northwest, which aligns with the areas of worst overall structural damage. Additionally, these zones had wind flow off bodies of water as opposed to land and experienced winds close to that shown in the HWind analysis for open terrain exposure (or slightly higher if the upstream fetch was over a smooth bay).

Figure 18. Distribution of roof system damage severity for asphalt shingle roofs by wind speed zone.

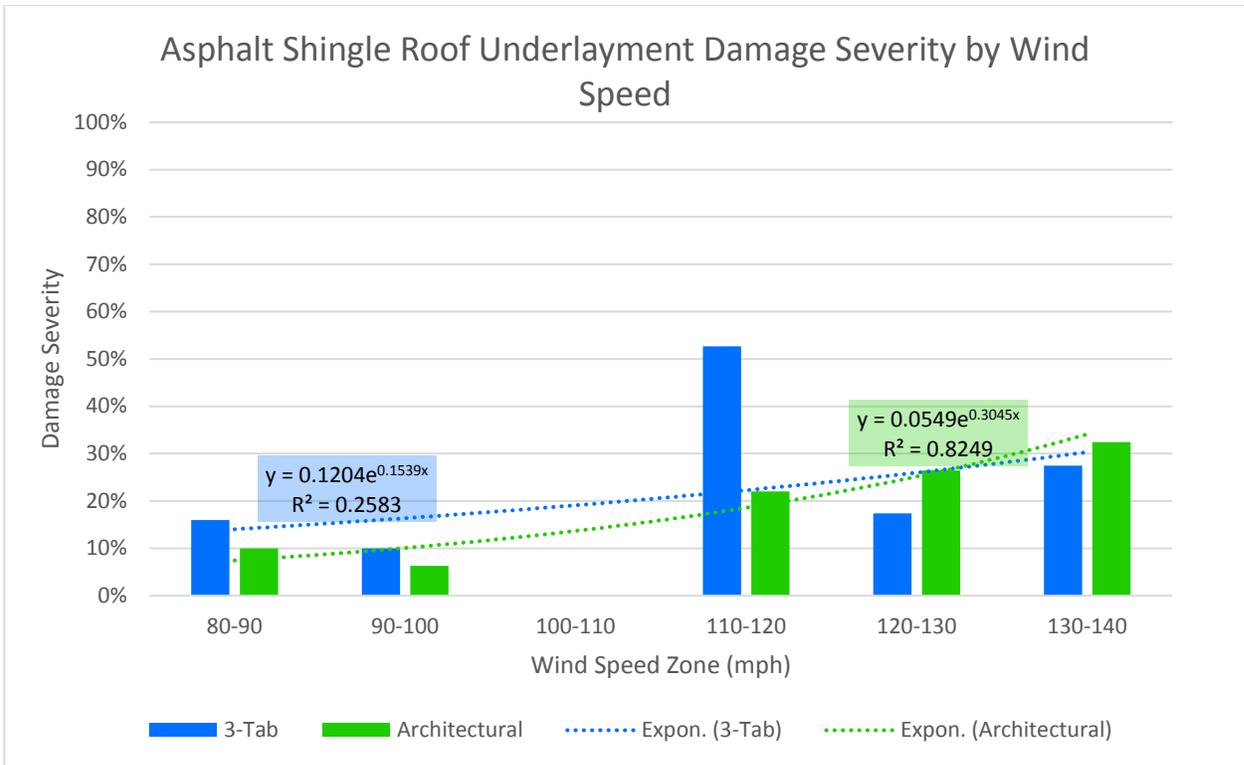
- As was seen for shingle damage severity (Figure 17), the spike in underlayment and roof deck damage severities for 3-tab roofs in Port Aransas North caused a poor fit in the vulnerability curves (Figures 19–20).

- However, the vulnerability curves for underlayment and deck damage severities on architectural shingle roofs were quite good (Figures 19–20; $R^2 = 0.82$ and 0.92 , respectively).

Figure 19. Underlayment damage severities on shingle roofs in neighborhoods with the same wind speed were combined to generate vulnerability curves. Exponential trend lines were fitted to the data, and are displayed with R^2 values. No data were collected in the 100–110 mph wind speed zone.

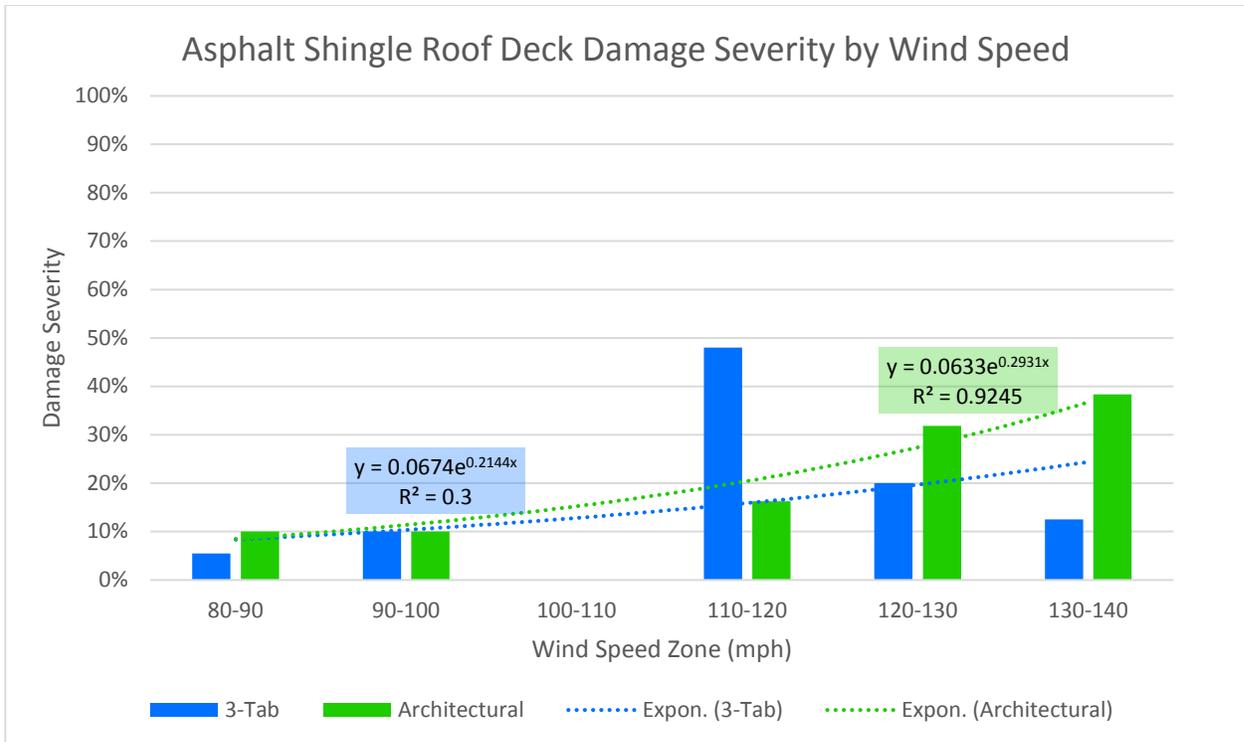
Figure 20. Roof deck damage severities on shingle roofs in neighborhoods with the same wind speed were combined to generate vulnerability curves. Exponential trend lines were fitted to the data, and are displayed with R^2 values. No data were collected in the 100–110 mph wind speed zone.

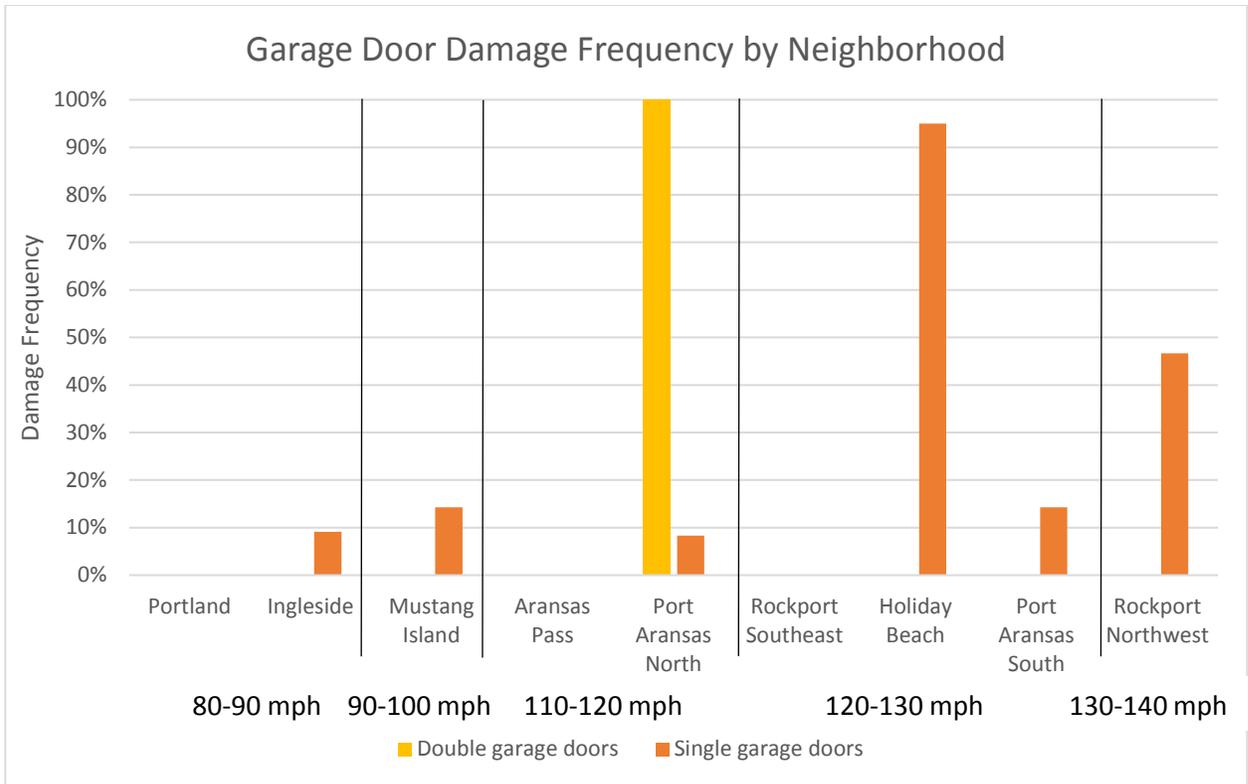
- Single-car garage doors had a higher damage frequency than double-car doors. This is consistent with results found by Kovar et al. (submitted 2018).
- Only one double-car garage door located in Port Aransas North, out of 62 in the entire dataset, had a failure. Double-car garage doors were found in all neighborhoods except Mustang Island and Holiday Beach.

Figure 23. Distribution of garage door damage frequency by door size and neighborhood. There was only one double-car garage door in Port Aransas North, and it was damaged, leading to 100% damage frequency there.

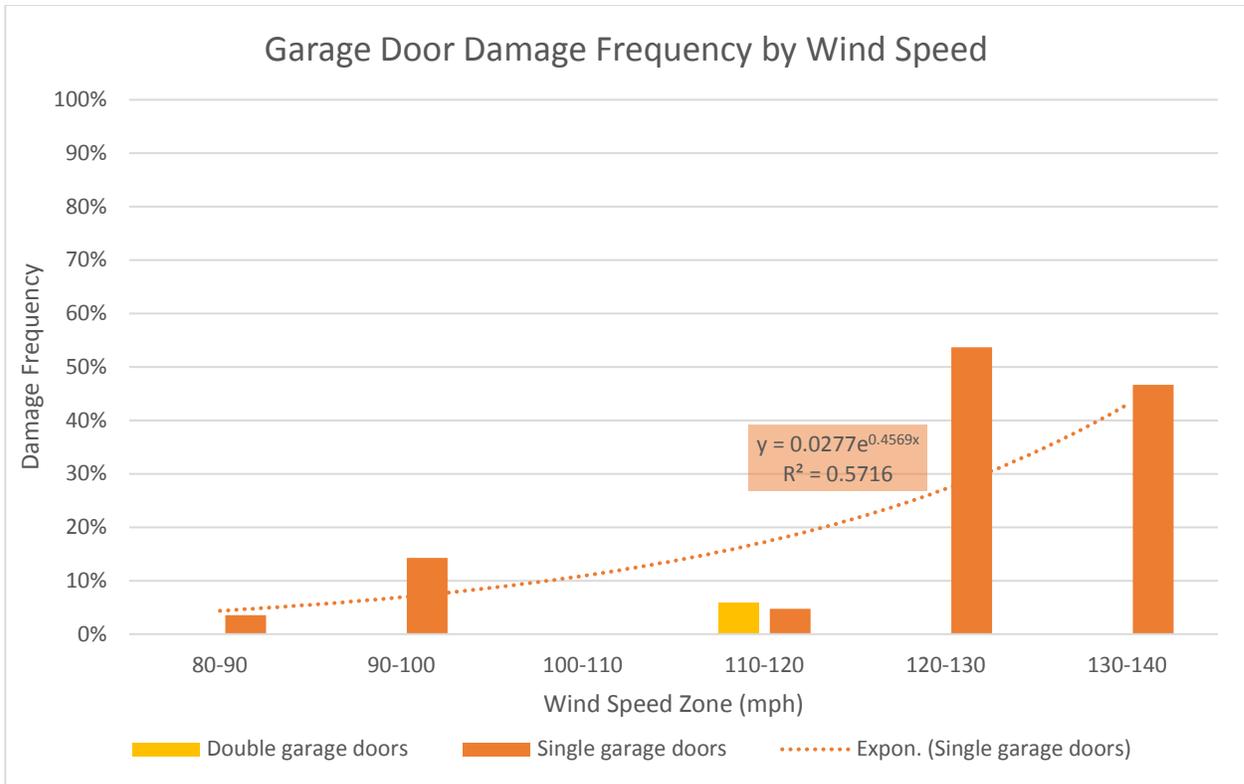
- Single-car garage door failure rates were highest in neighborhoods with wind speeds of 110 mph or higher. Single-car garage doors were present in all neighborhoods except Rockport Southeast.
- There is a general trend of increasing garage door damage frequencies with increasing wind speed (Figure 24). However, the relationship is not as strong (R^2 value of 0.57) as shingle damage frequencies.

Figure 24. Garage door damage frequencies in neighborhoods with the same wind speed were combined to generate a vulnerability curve for single-car garage doors. An exponential trend line was fitted to the data, and is displayed with R^2 values. No data were collected in the 100–110 mph wind speed zone. There was only one failed double-car garage door and thus not enough data points to fit a vulnerability curve.
