HURRICANE MICHAEL AT A GLANCE: Considerations for Property Insurers

INSIGHTS FROM THE IBHS POST-EVENT INVESTIGATION

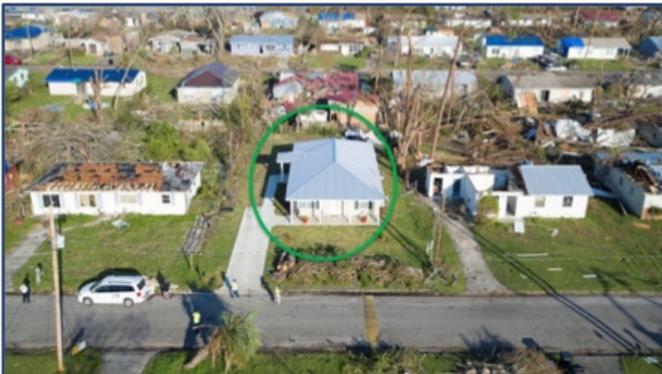
- Resilience was successfully demonstrated across all levels of home values.
- Newer construction performed better than older construction. Updated building codes are effective in minimizing damage.
- FORTIFIED construction performed well in the hardest-hit area of Mexico Beach. The Habitat Strong™ homes in Panama City also performed very well. These structures incurred far less damage than many of the surrounding structures at wind speeds near the local design level.

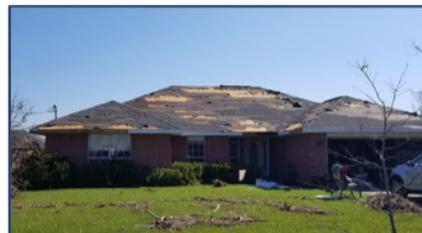
- Loss of roof cover occurred across the entire impacted area.
- Metal roofs were damaged less frequently than asphalt shingle roofs.
- Soffit and fascia damage generally occurred at wind gusts of 110 mph or greater.
- Roof decking damage generally occurred at wind gusts greater than 130 mph.
- Roof structural damage generally occurred where the gust wind speed was 140 mph or greater.
- Hip roofs performed the best overall, compared to gable and gable-hip roofs, consistent with historical research.
- Total collapse generally occurred only where the peak wind gusts were 150 mph or greater.
